UNDERWATER BRIDGE INSPECTION REPORT

WisDOT ID No.: P-40-794

Date Inspected: 06/03/08

Becher Street Over The Kinnickinnic River

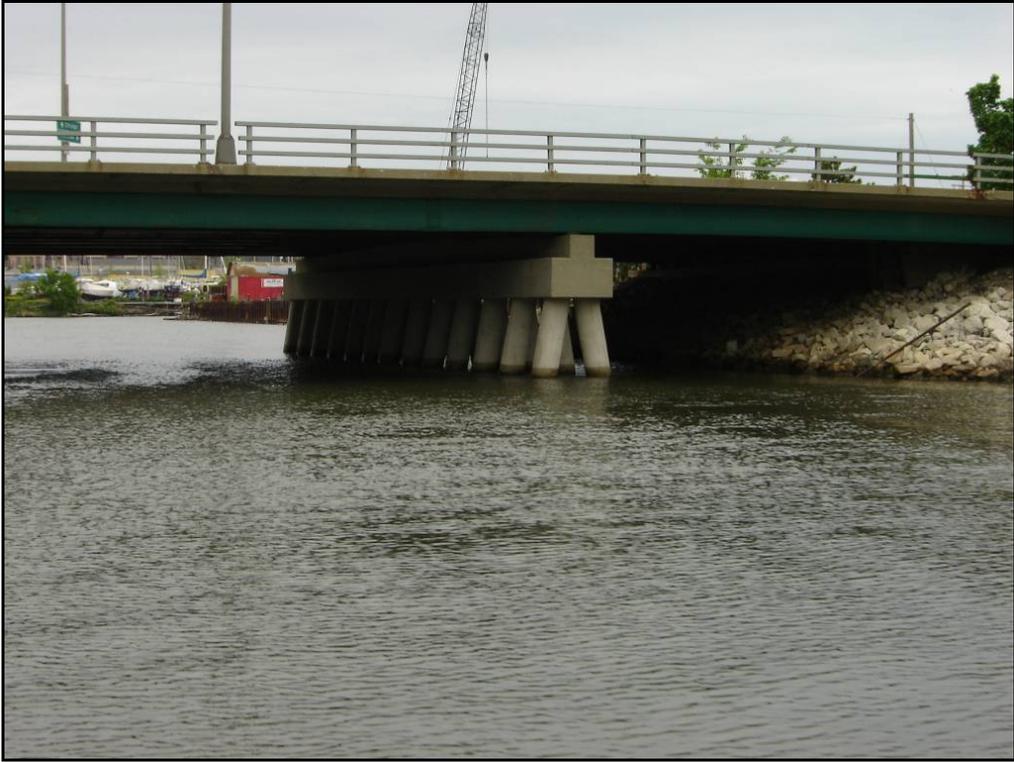
1. All concrete jackets extended into the channel bottom and were in good condition with no notable defects.
2. The channel bottom at Bent 1 consisted of gravel and 6 in. diameter and smaller cobbles with random grout bags with no penetration.
3. The channel bottom at Bent 2 consisted of firm silt with 2 in. of penetration with a standard probe rod.

Photograph 3: View of Bent 2, looking northeast.

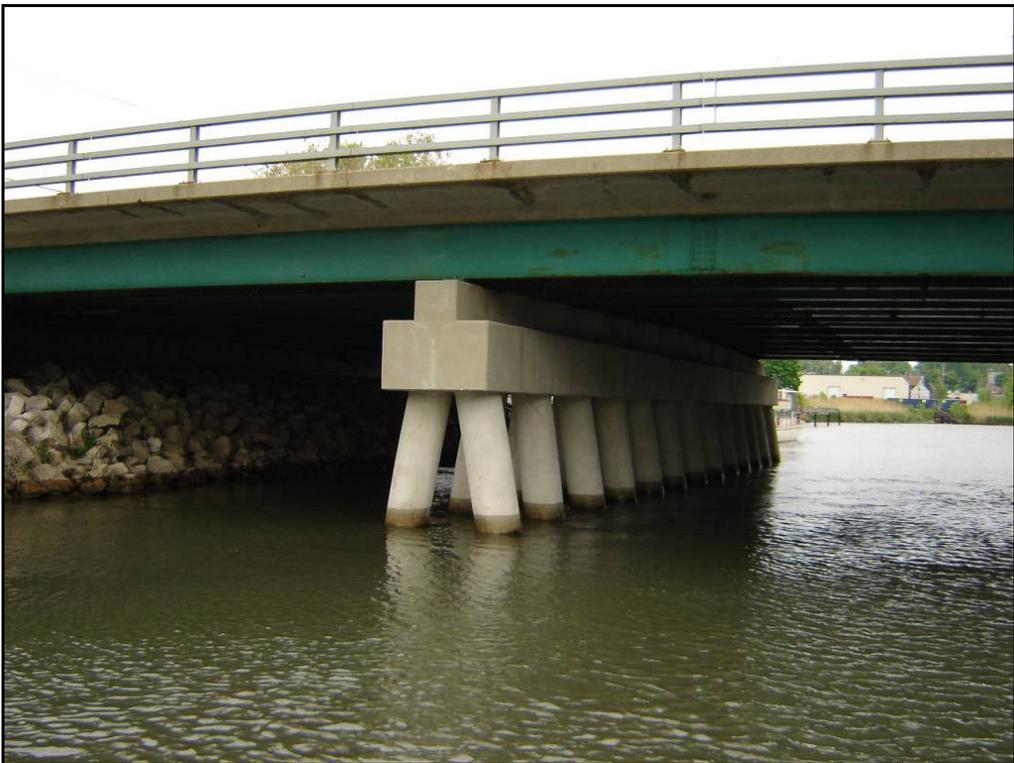
Photograph 4: View of Bent 1, looking northwest.

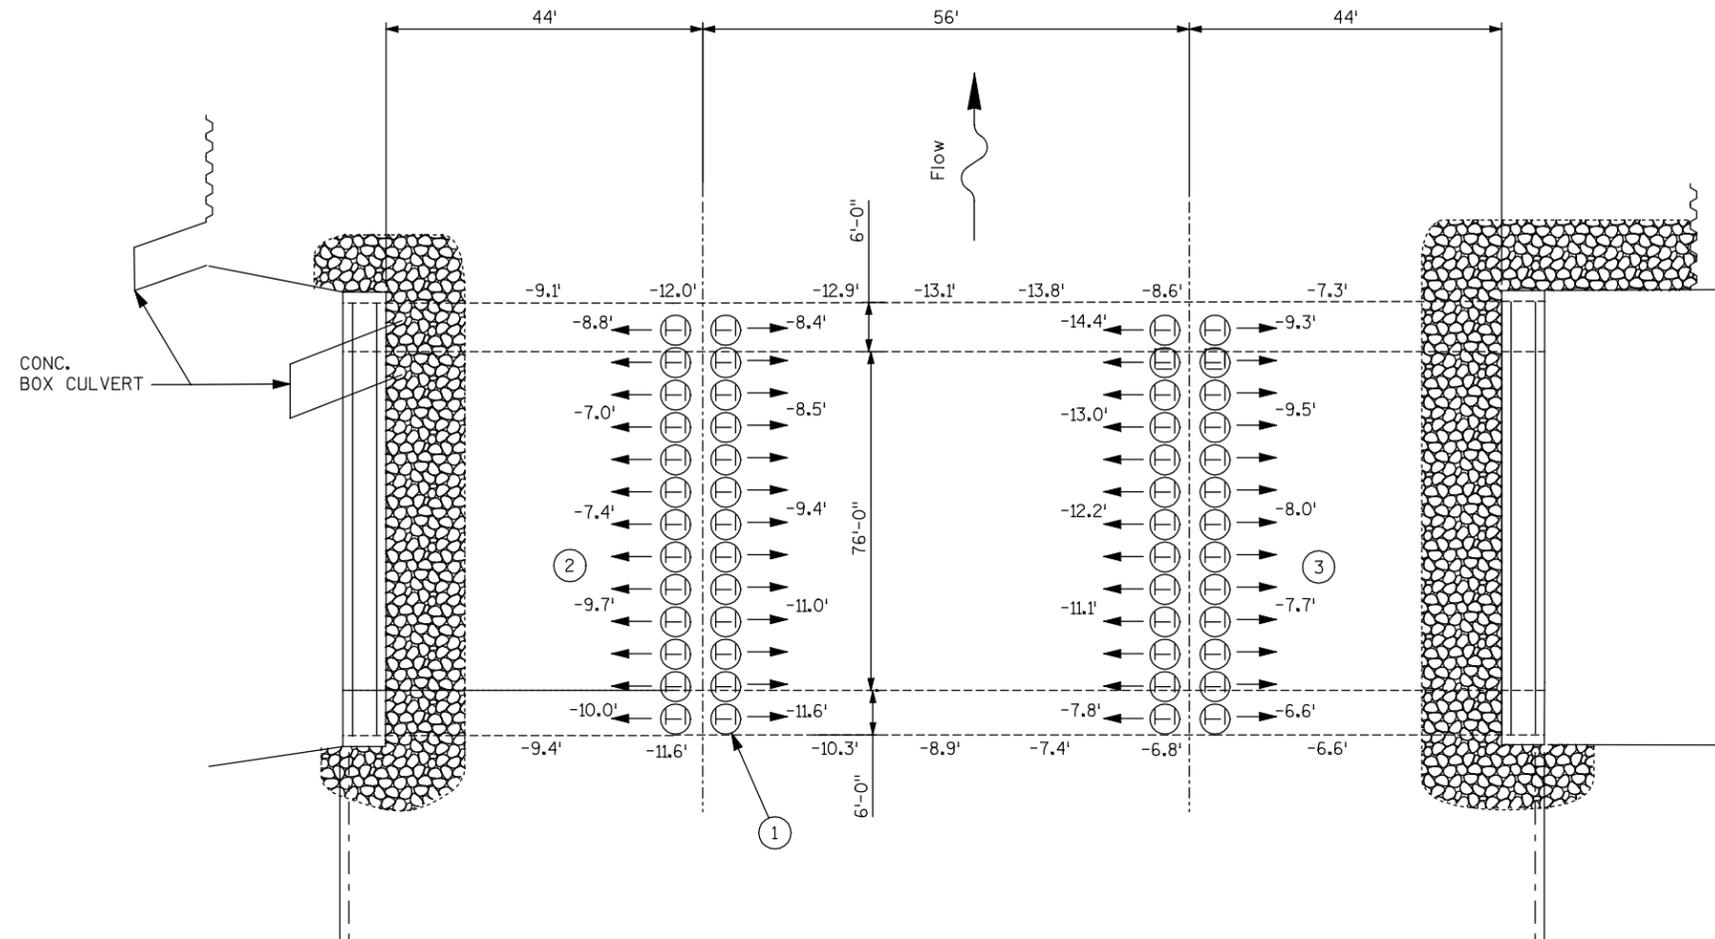
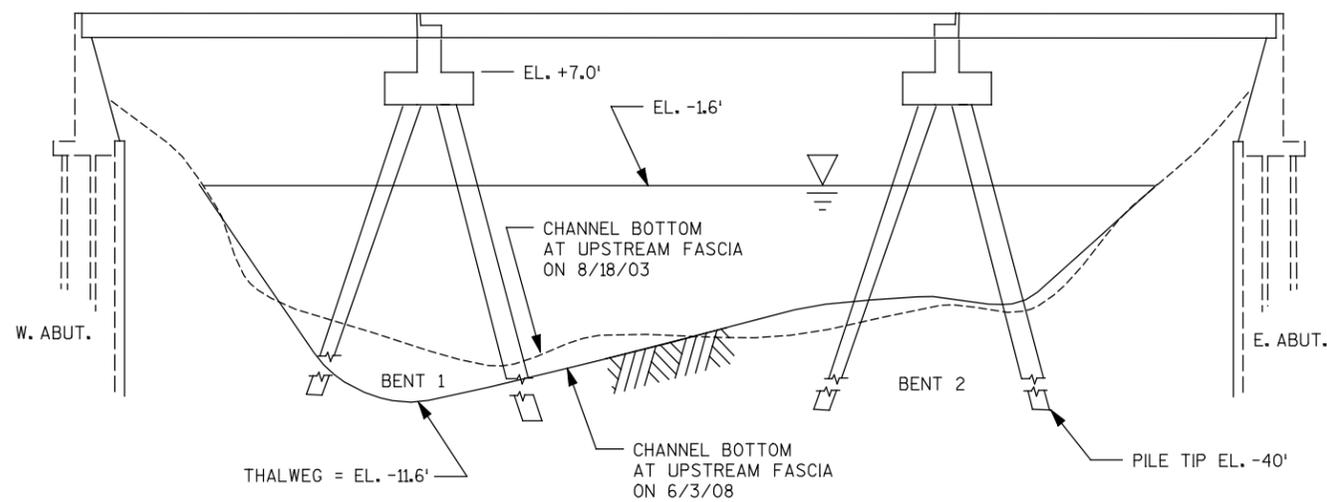
UNDERWATER INSPECTION PLAN

B. Comprehensive Report of Deficiencies (Selected inspection notes shown on Figure 1)

Bents 1 and 2:
