**W. Becher St. S 1<sup>st</sup> St to S 4<sup>th</sup> St  
16" Water Main – Shaft and Tunnel Below  
The Kinnickinnic River**

## INSPECTION 2014

PHOTOS EAST SHAFT -11/4/14 and 11/5/14

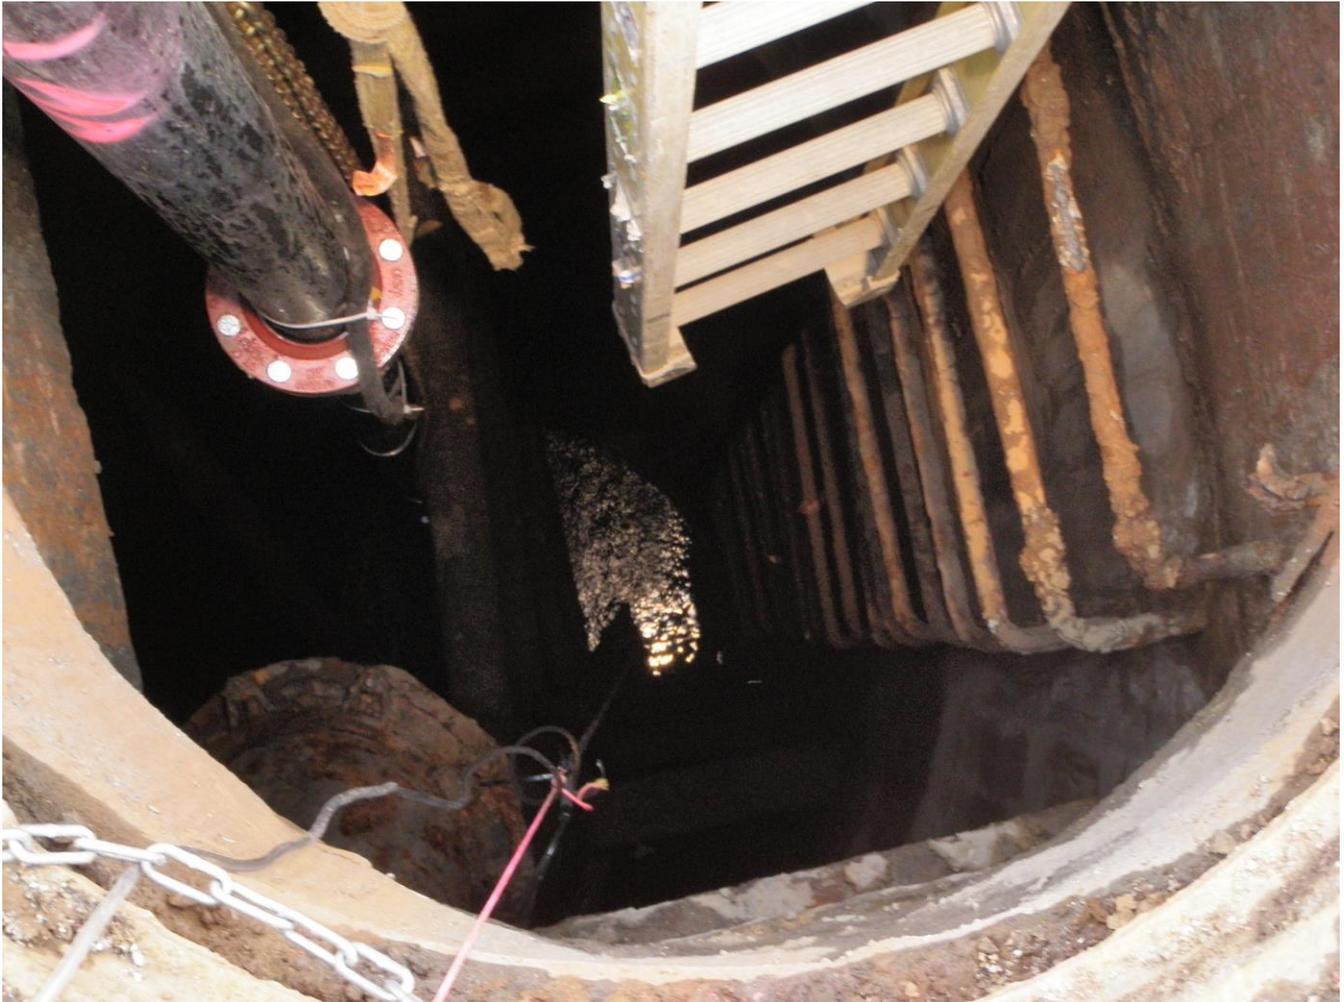
- East MH Looking Down

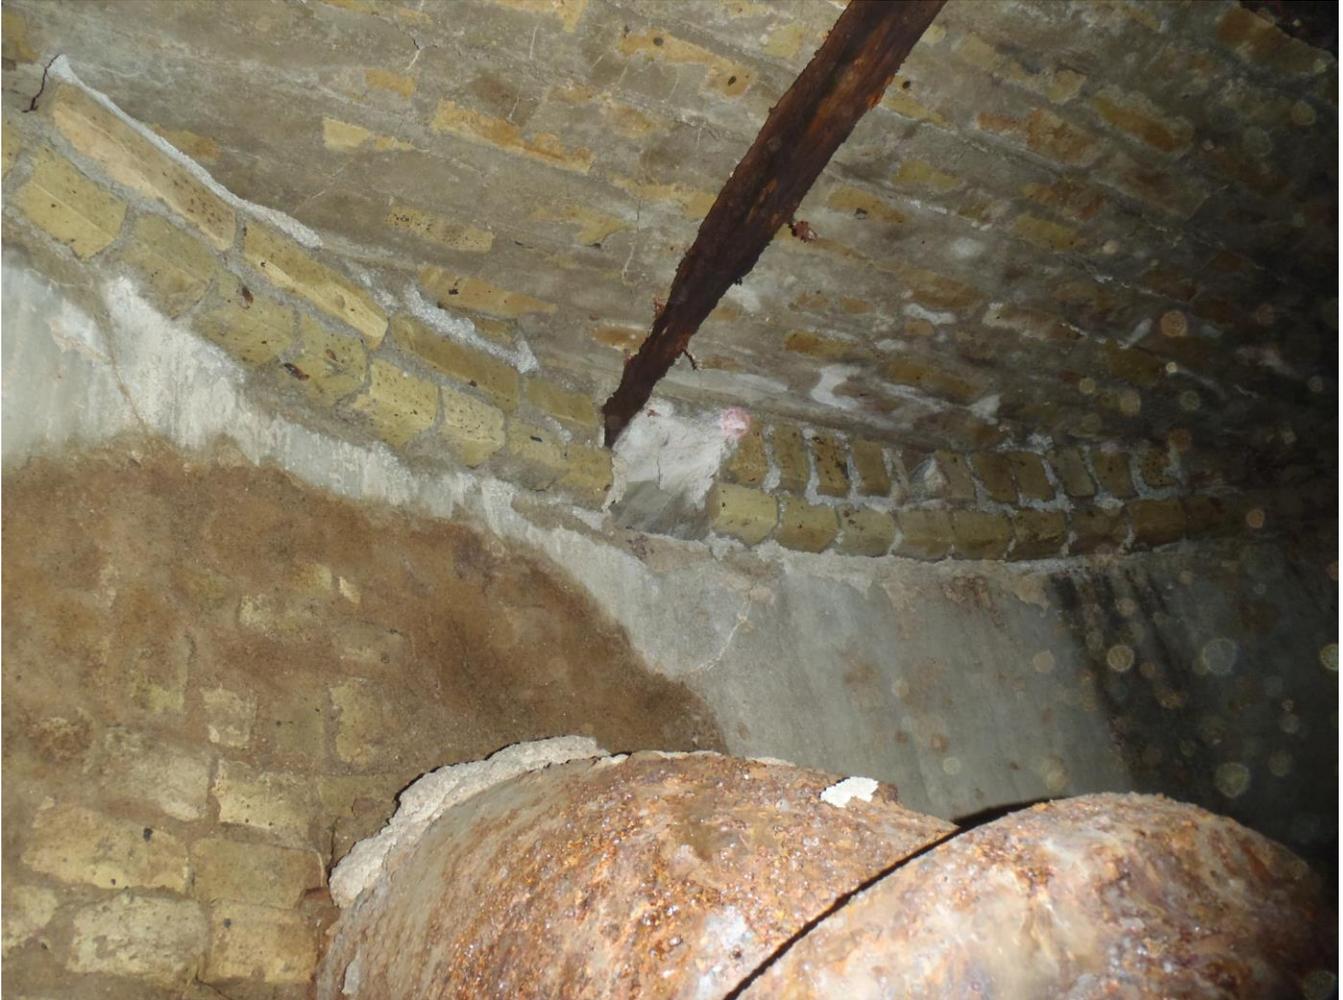
- Shaft Ceiling Beams and Brick/Mortar

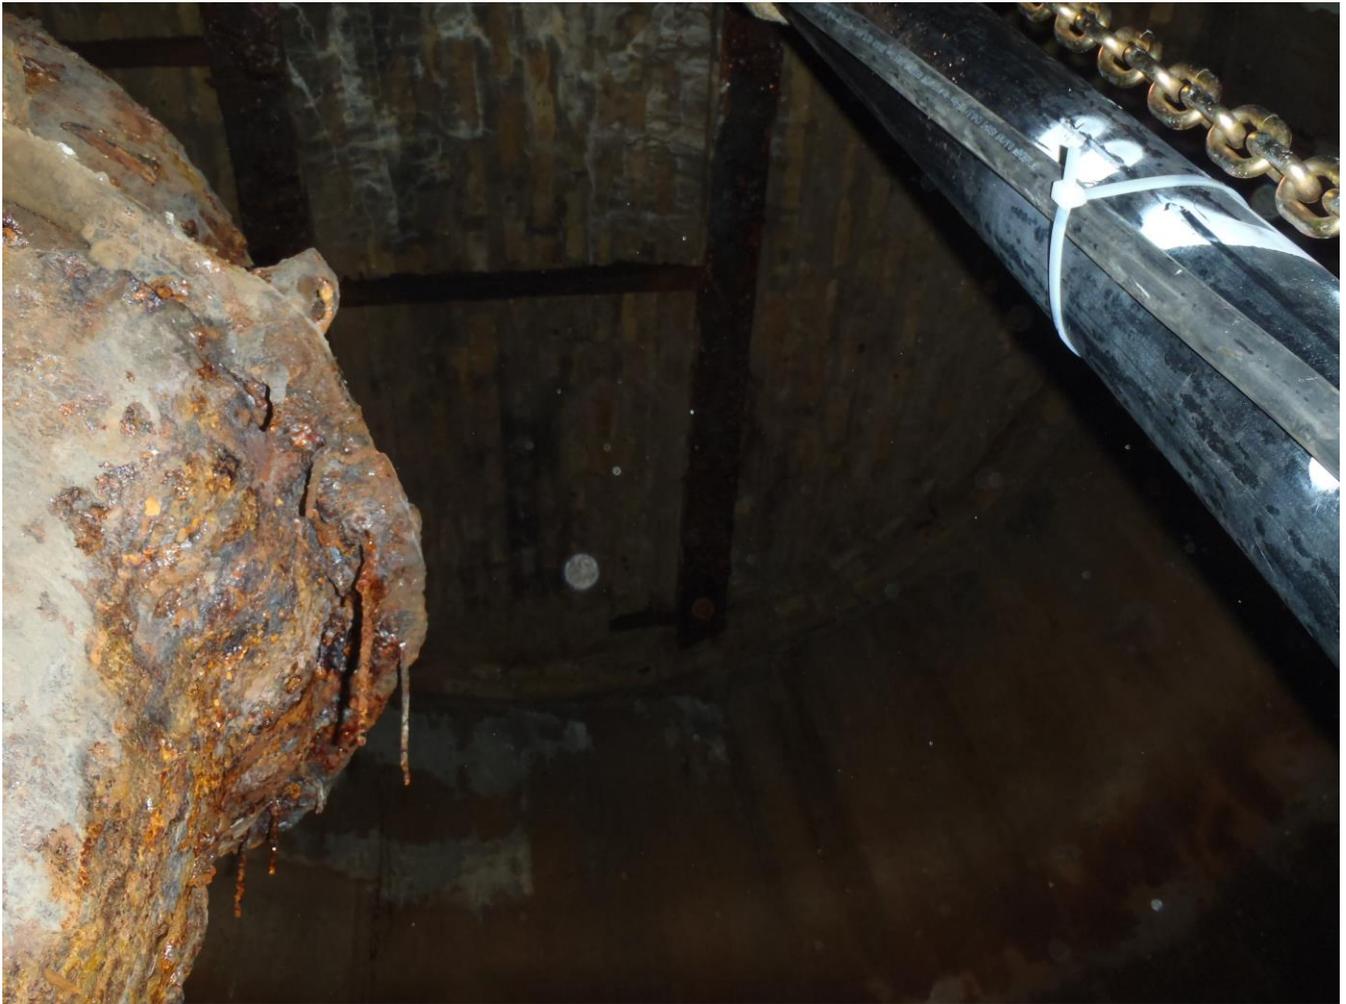
- Shaft Ceiling Beams and Brick/Mortar

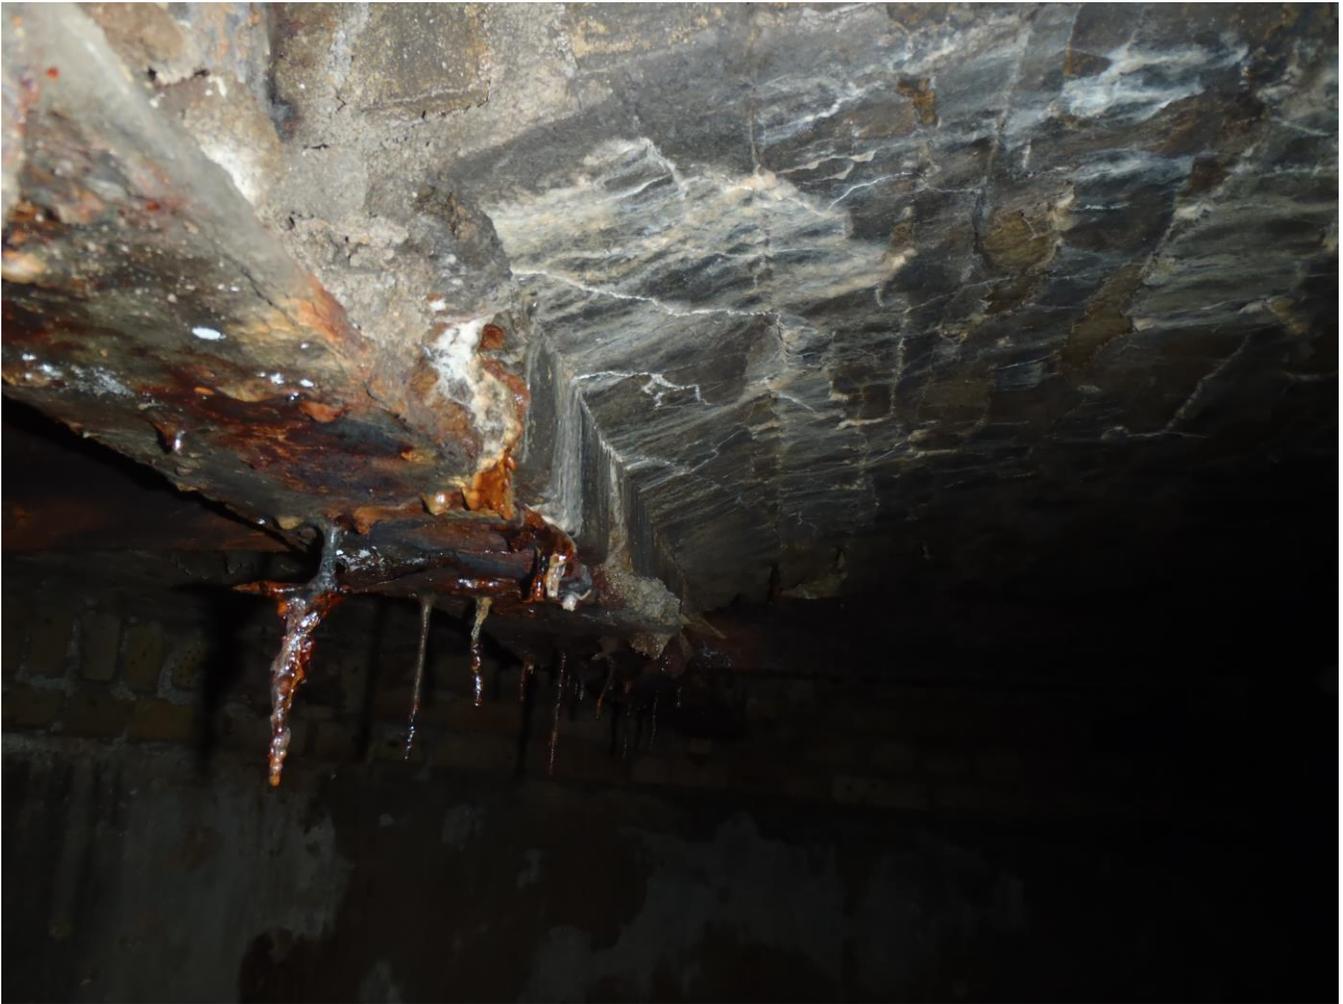
- Shaft Ceiling Beams and Brick/Mortar Arch

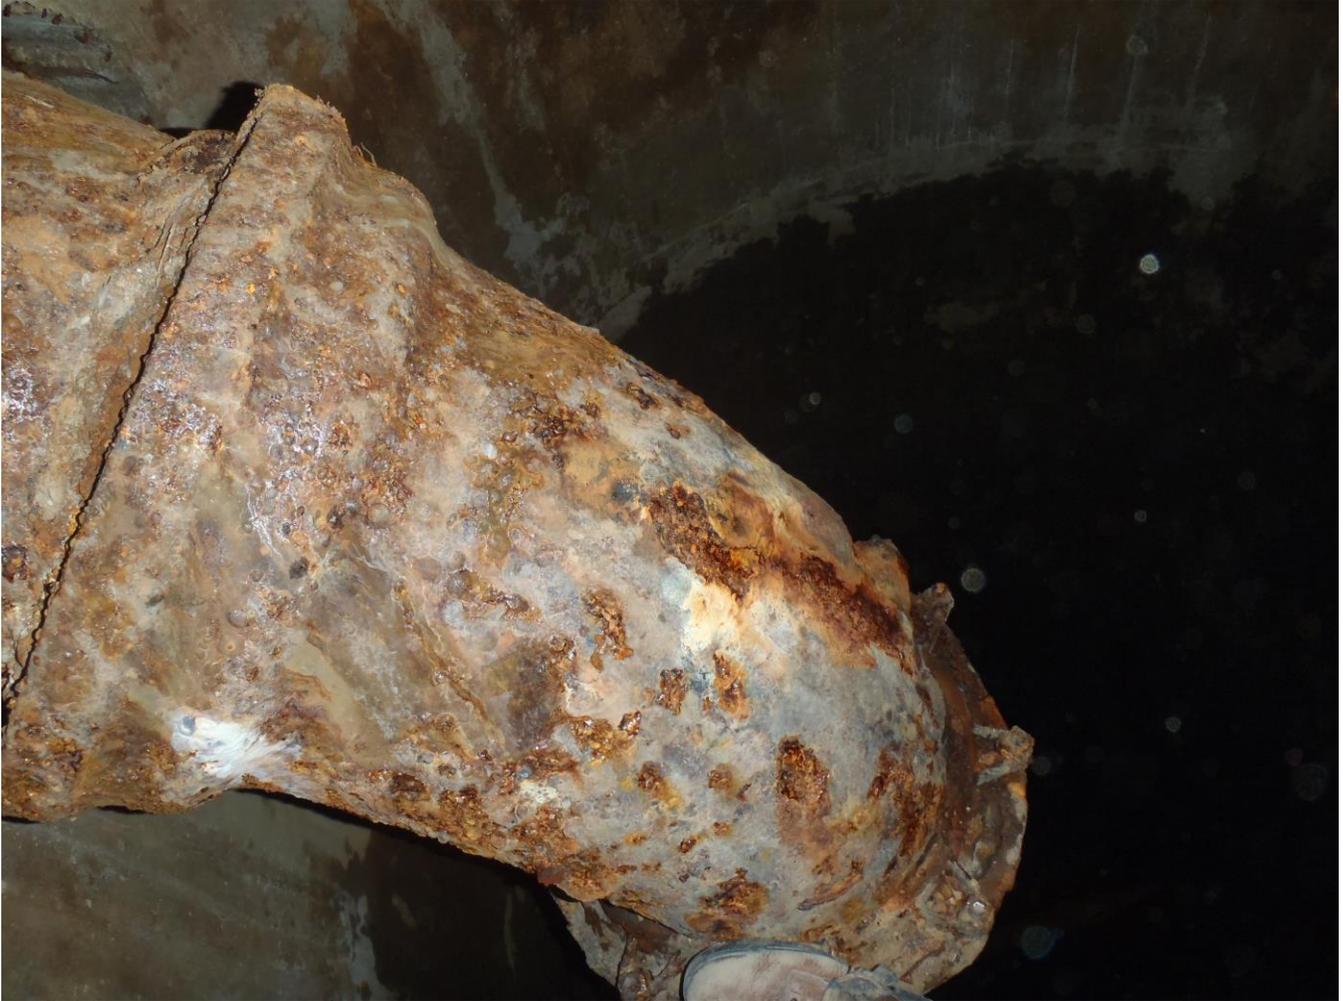
- Condition appeared to be sound
- Few circumferential cracks
- **Water Main on ES contained a Bell Joint Repair Clamp on the spigot joint on the top 45 degree elbow**
- **The next joint down (12 FT) was location of 2007 failure; noticeable movement of lead and lateral support from wood maple hearts appeared to have moved.**
- Wood supports intact and 4 -5 beams installed per joint installed on face of bell
- Shaft Ceilings Beams, brick arch and mortar?

- 45 Degree Elbow with bell joint repair clamp

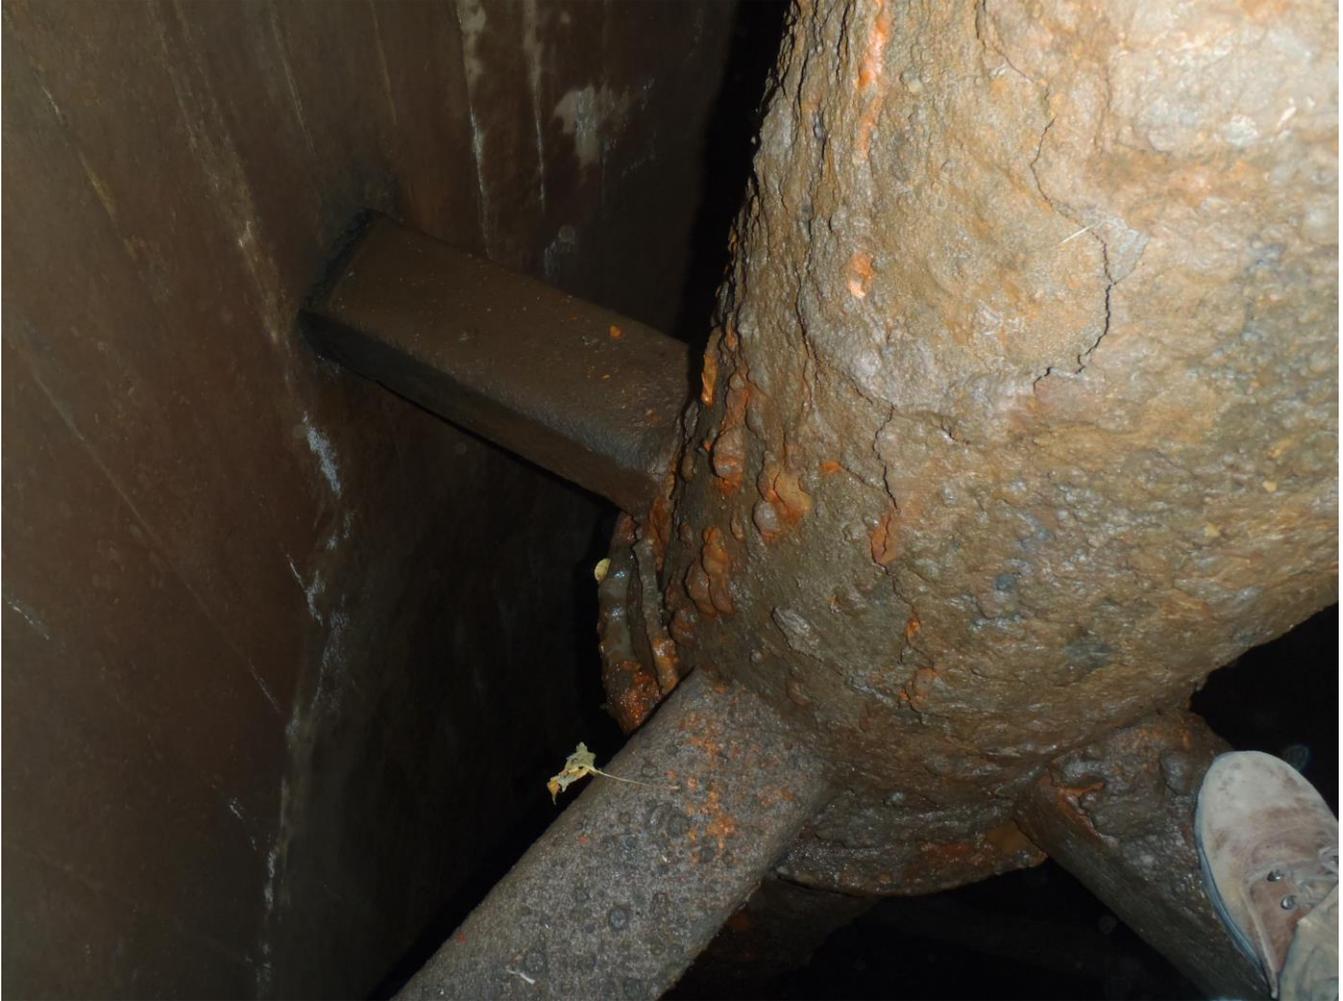
The Milwaukee Water Works identified a leaking vertical joint in the East Shaft of the W Becher St main November 2007. It was determined that the main should be taken OOS and options for repair/replacement should be evaluated. No repairs were implemented and the main has remained OOS.

- Top of leaking joint
- Wood beams for lateral support

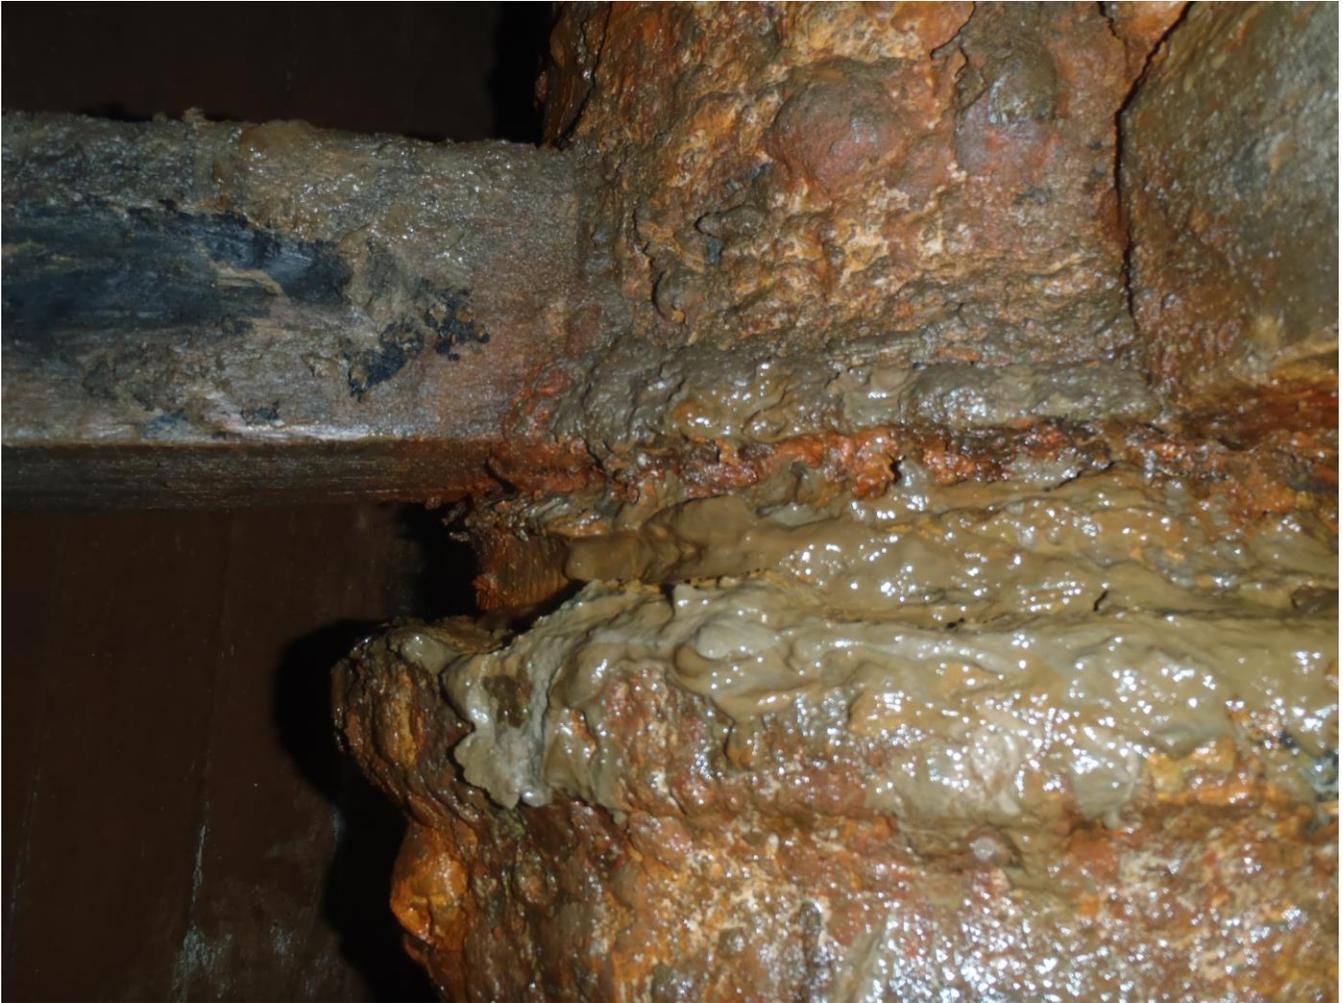
- Side of leaking joint

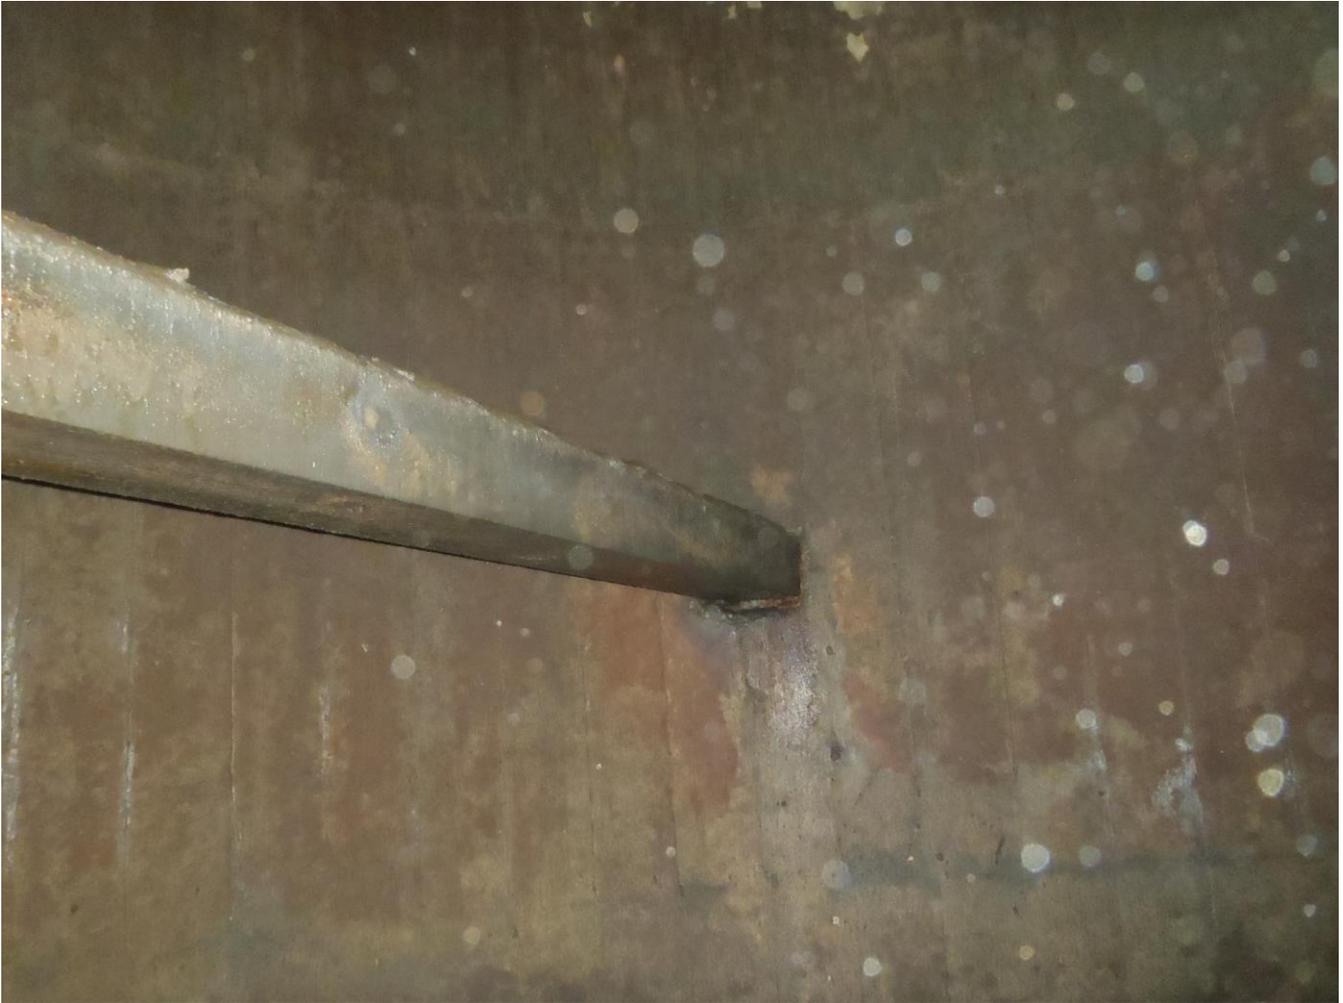
- Wood support at shaft wall

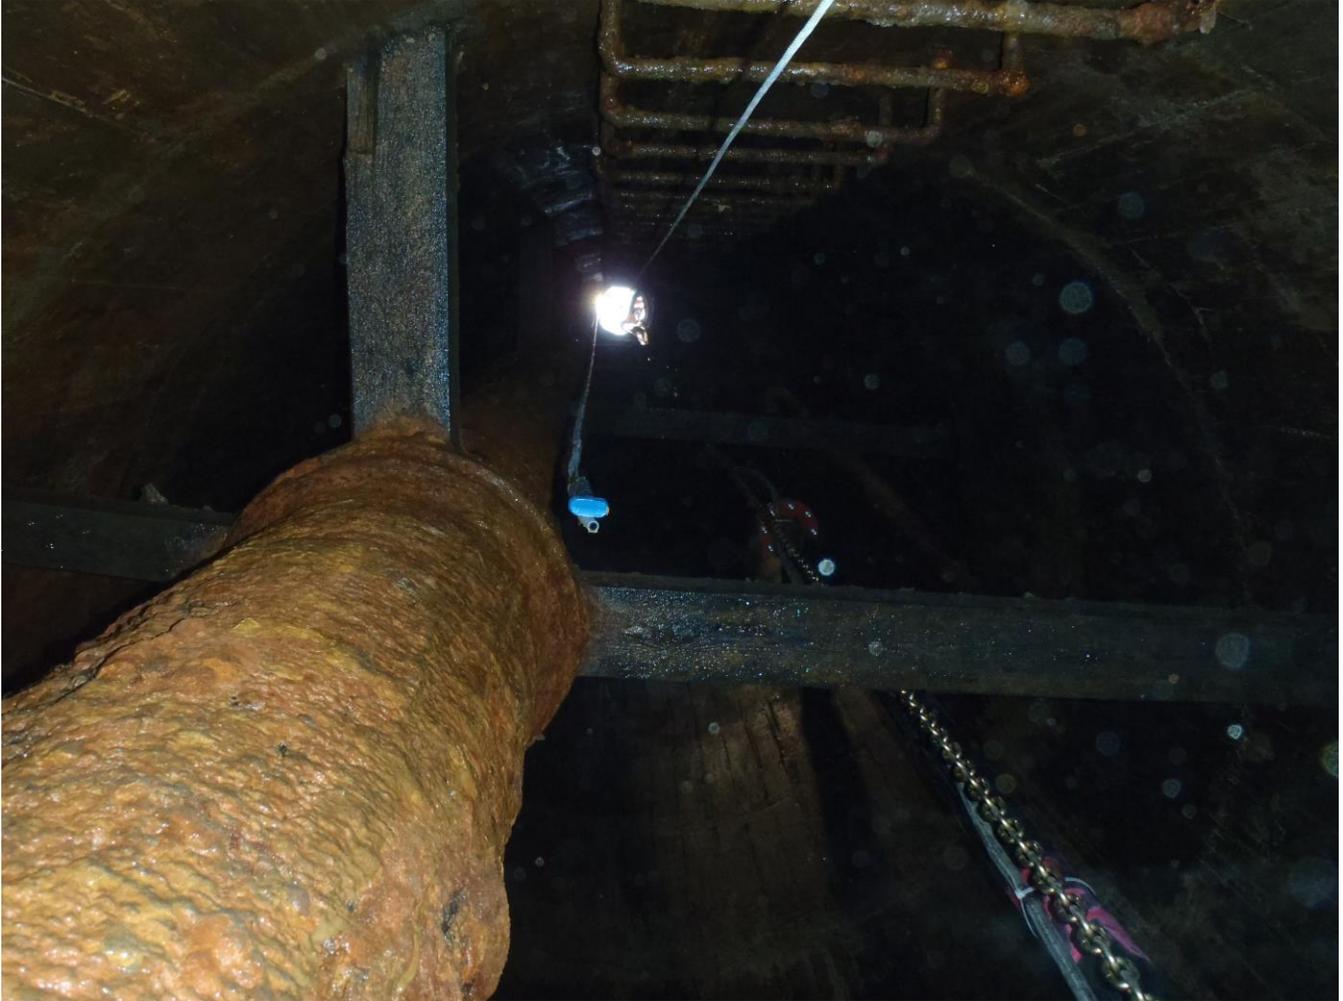
- Shaft Floor Looking Up

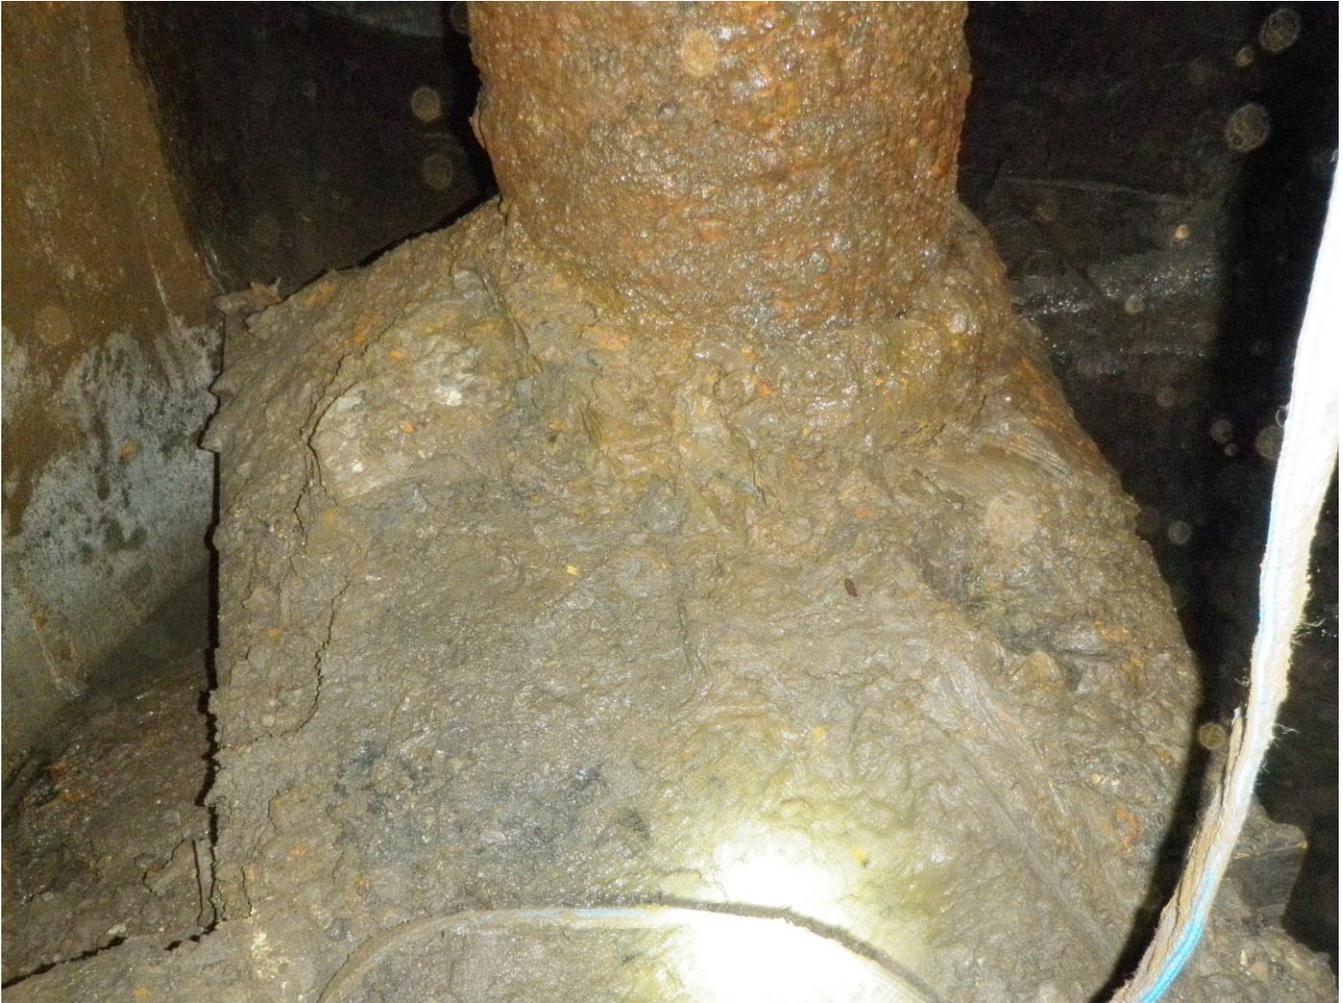
- Anchor Block at Bottom 90 degree bend

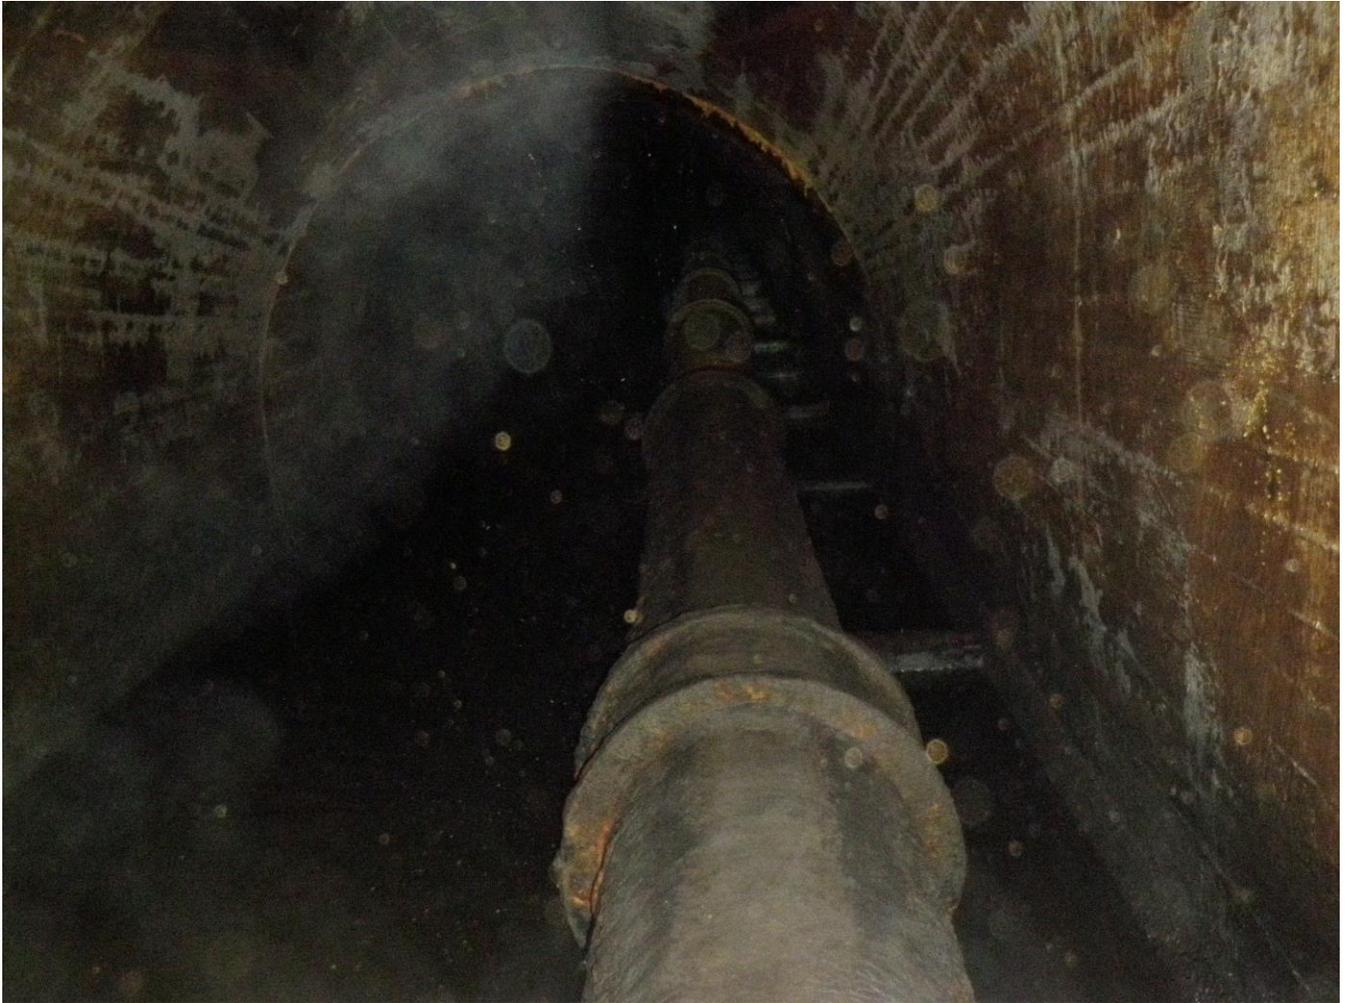
- Pipe in Tunnel to west
- Sleeve
- Pipe Supports

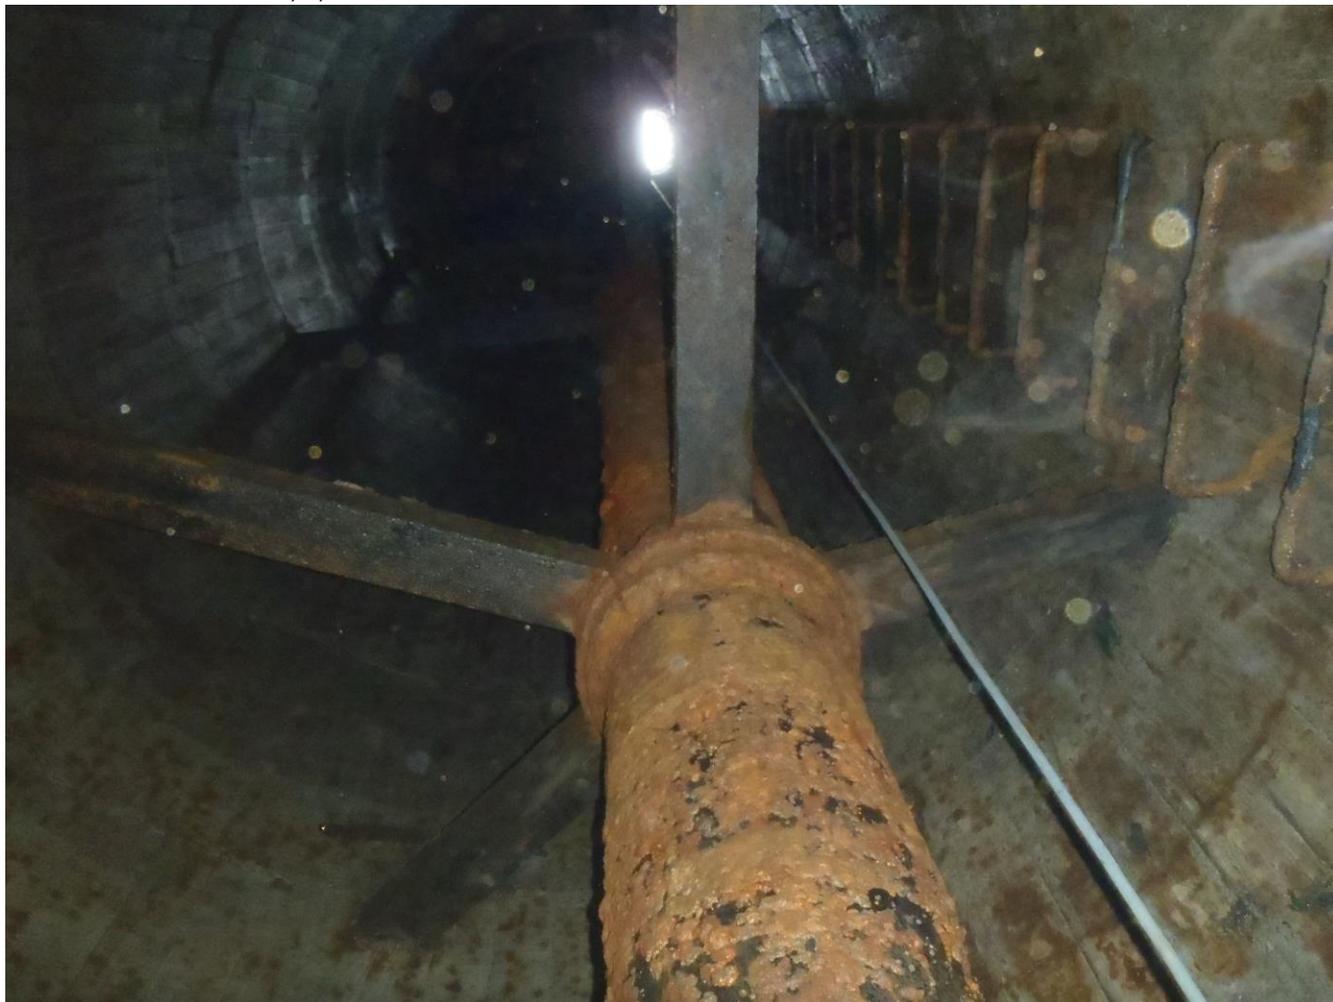
- Beam Supports

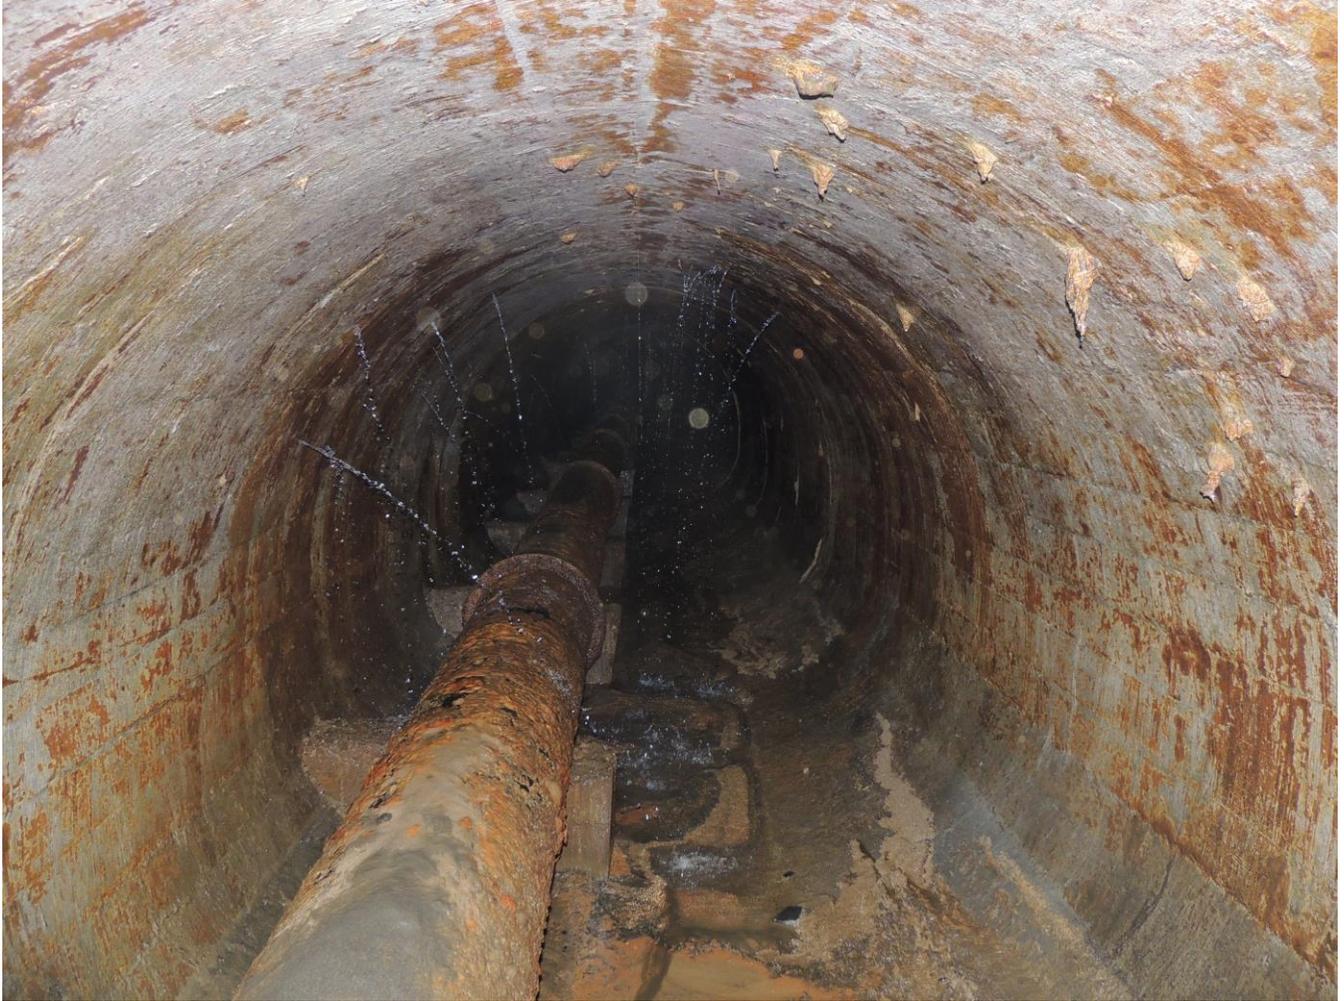
- Water main installed towards North side of tunnel
- Water main supported with 2 concrete pipe supports per 12 foot pipe
- Concrete anchor at bottom 90 degree bend fully encased
- Tunnel appeared to be sound
- No entry was made further than 10ft
- With light could see 10-12 joints in tunnel
- Water leaking from cracks in tunnel several locations
- Observed drains at bottom of tunnel through wall

- Pipe Looking East
- Water Infiltration
- Pipe Supports

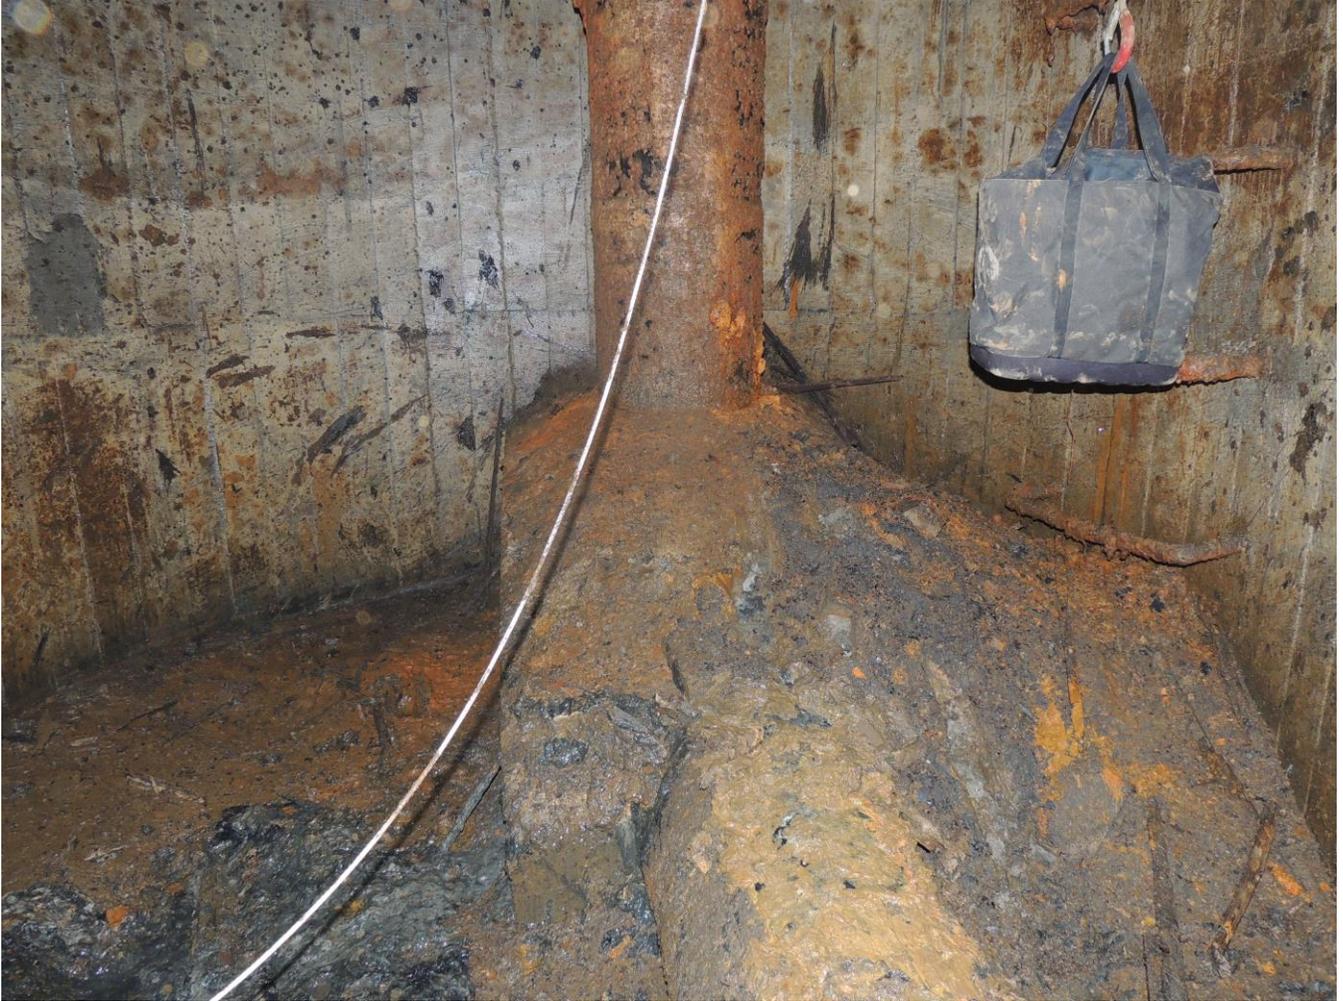
- Anchor Block at Bottom 90 degree bend
