**LIMITED ASBESTOS AND LEAD PAINT SURVEY REPORT
R-163: RIVERSIDE PUMPING STATION
BACKUP POWER GENERATION**

**RIVERSIDE BACKUP POWER GENERATION
PROJECT**

**1311 E CHAMBERS STREET
MILWAUKEE, WISCONSIN**

**Revised October 28, 2009
Liesch Project Number: 6800833.00
TN Subcontract # SC-2008059-6624**

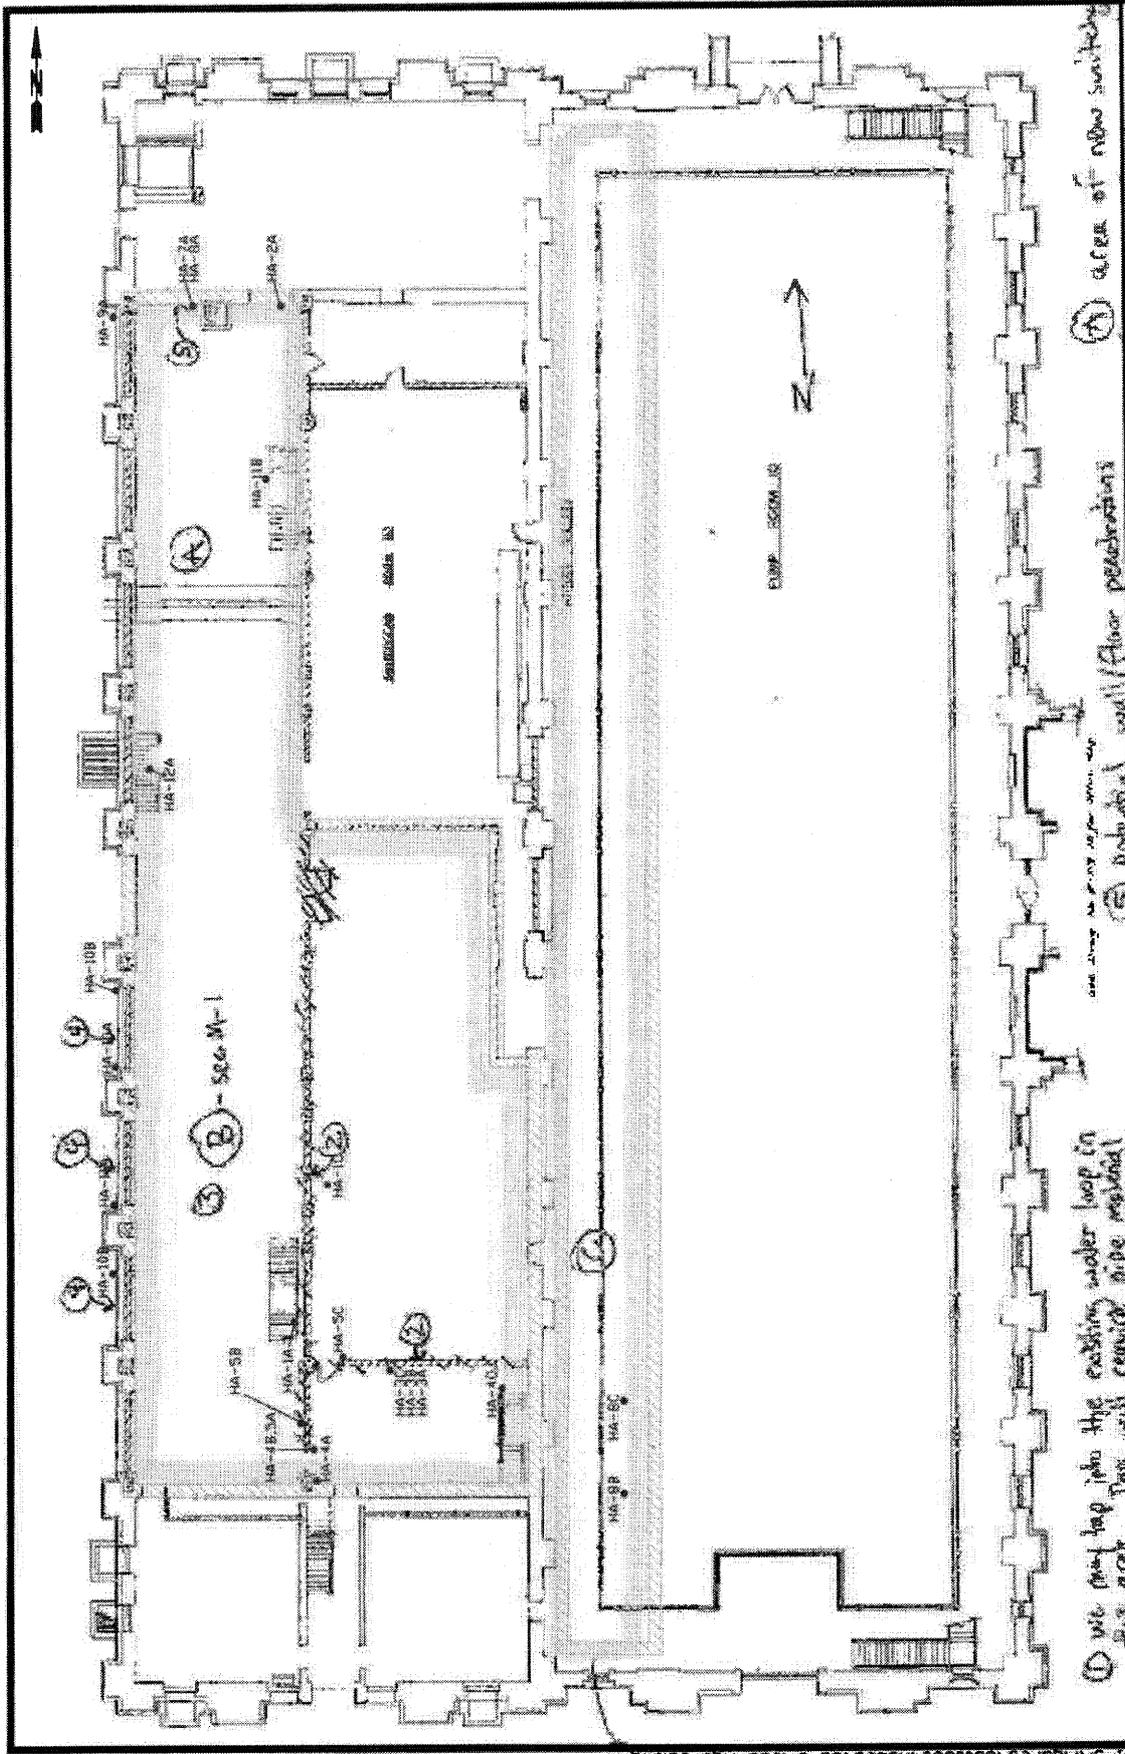
Appendix A, Figure 3 shows where the samples of suspect ACM were collected. Refer to **Appendix B, Table I** for additional information regarding the locations and estimated quantities (if applicable) of identified ACMs. IATL's analytical report is included in **Appendix C**.

- Gray felt pipe insulation on Pump Room 10 water line loop – Not Quantified
- Pipe fittings on Pump Room 10 water line loop – Not Quantified
- Off white 12" x 12" floor tile and black mastic within Room 117 (including passageway) – 640 square feet
- Vermiculite insulation within exterior cinder blocks (Assumed) – Not Quantified

- In accordance with the State of Wisconsin and Federal regulations regarding ACM, all friable and non-friable materials that may become friable, with greater than 1% asbestos which will be disturbed, must be identified and removed prior to the start of renovation activities (except as noted in the next bullet item). All rules and regulations will need to be followed, including, but not limited to: notification, permit acquisition and disposal of ACM at a landfill approved to accept asbestos containing waste. An asbestos abatement contractor licensed by the State of Wisconsin must perform the work. Workers, supervisors, and air monitoring personnel must be trained, certified and licensed according to EPA and State of Wisconsin regulations. Regulated asbestos abatement projects require a ten (10) calendar day notification to the Wisconsin Department of Health and Family Services (WDHFS) prior to the start of abatement. The City of Milwaukee Health Department requires a separate project permit.

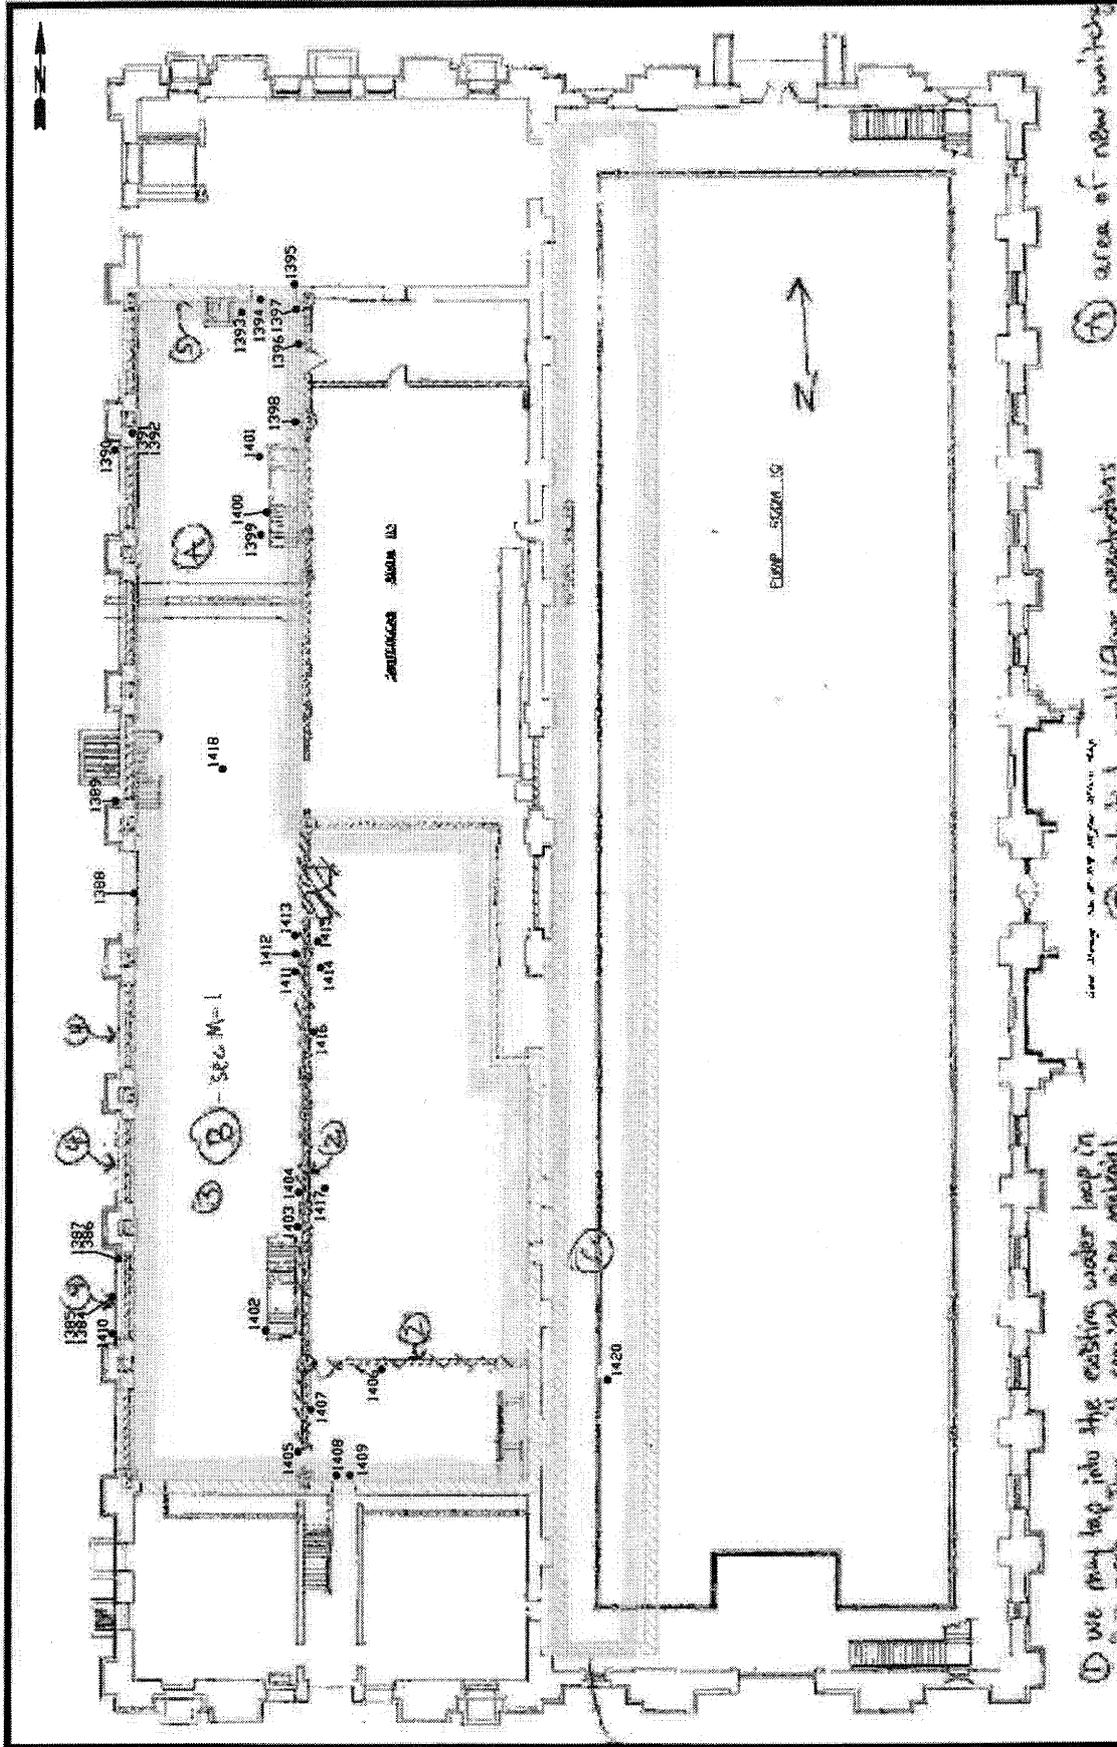
Milwaukee Water Works Riverside Station
Lead Sample Location Map

Liesch did not identify areas of damaged painted surfaces. **Appendix A, Figure 4** shows where the samples of suspect lead based paint were collected.

Liesch did not identify damaged LBP painted surfaces at the time of the Survey. Wisconsin considers paint to be lead containing at 0.7 milligram per square centimeter (mg/cm^2) by weight. Lead based paint that is attached to the substrate it has been applied to can be sent to a construction/demolition landfill. Lead based paint may need to be removed if the material that it is attached to is going to be recycled.
