Bridge 814/P-40-0509: S Howell Avenue over UPRR
Impact Damage Photos

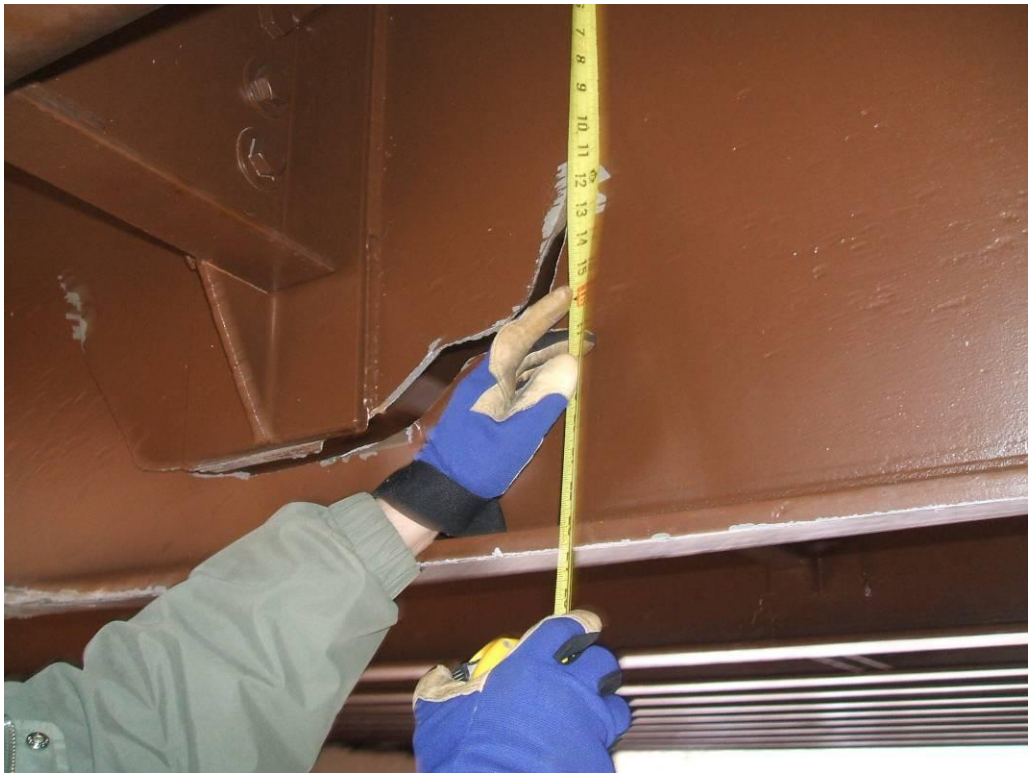
View of Girder 2 fractured web.
