UNDERWATER BRIDGE INSPECTION REPORT

WisDOT ID No.: P-40-794

Date Inspected: 06/03/08

Becher Street Over The Kinnickinnic River

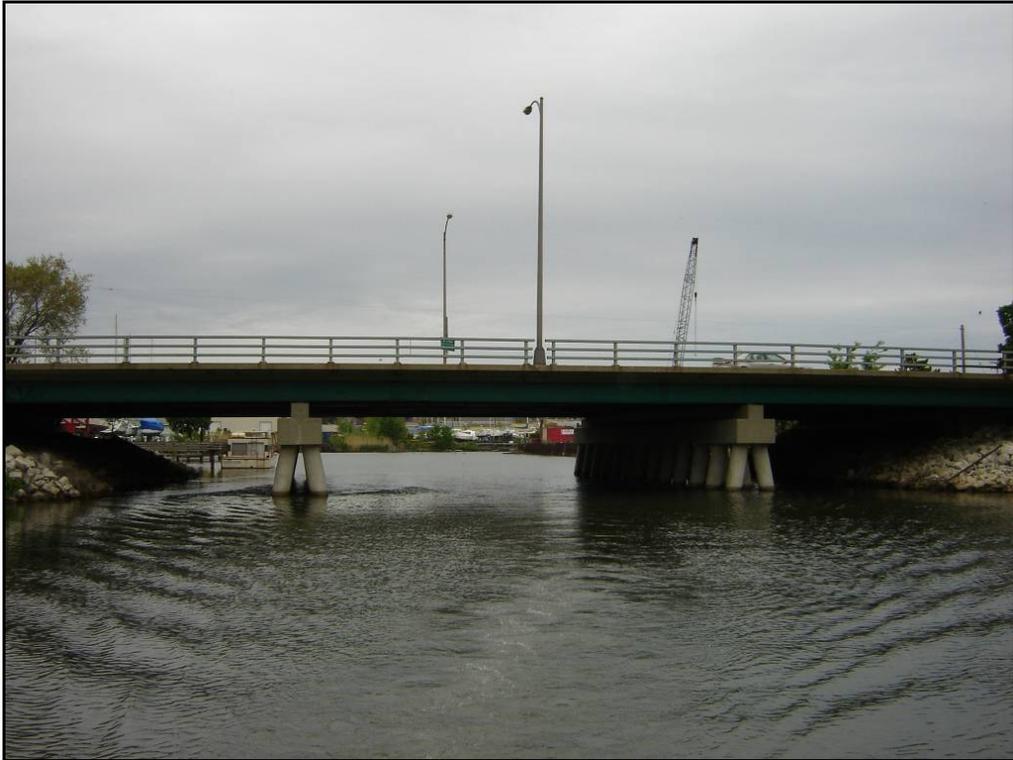
Photograph 1: Overall view of bridge P-40-794, looking north.

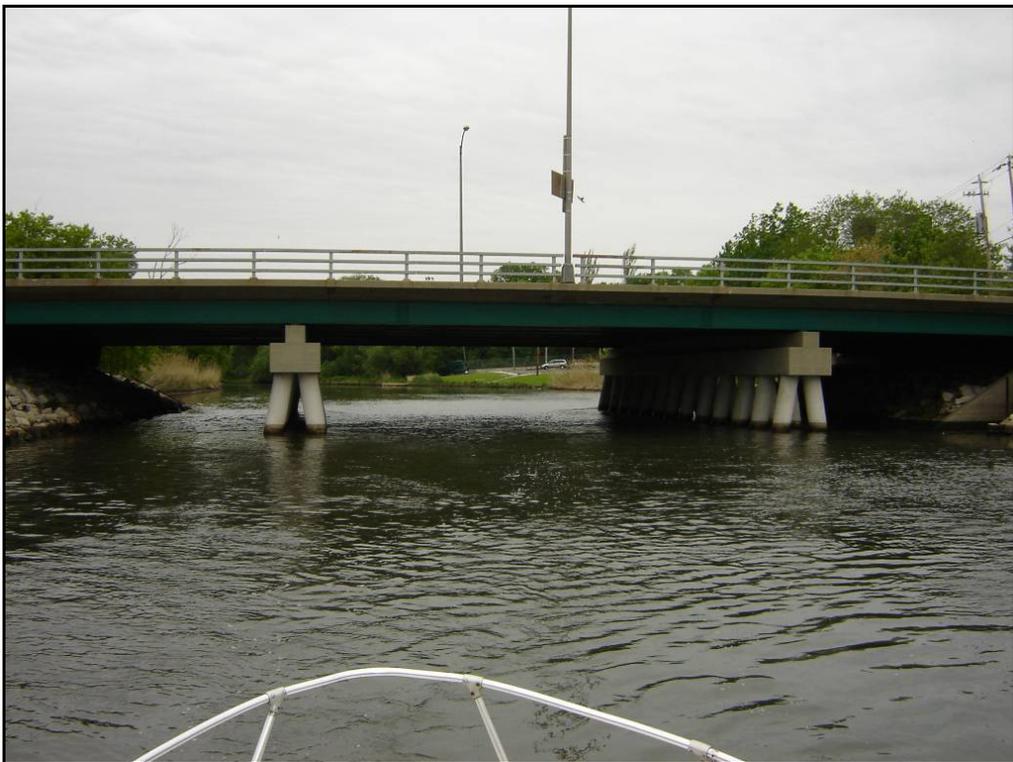
Photograph 2: Overall view of bridge P-40-794, looking south.

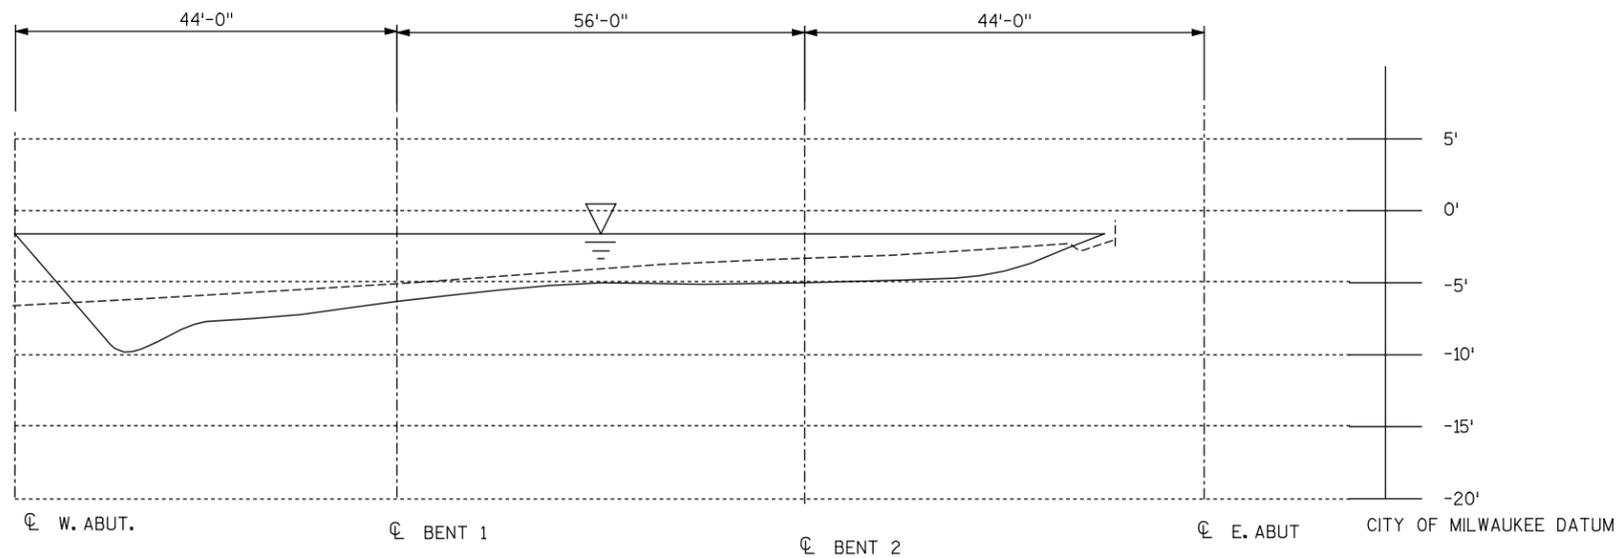
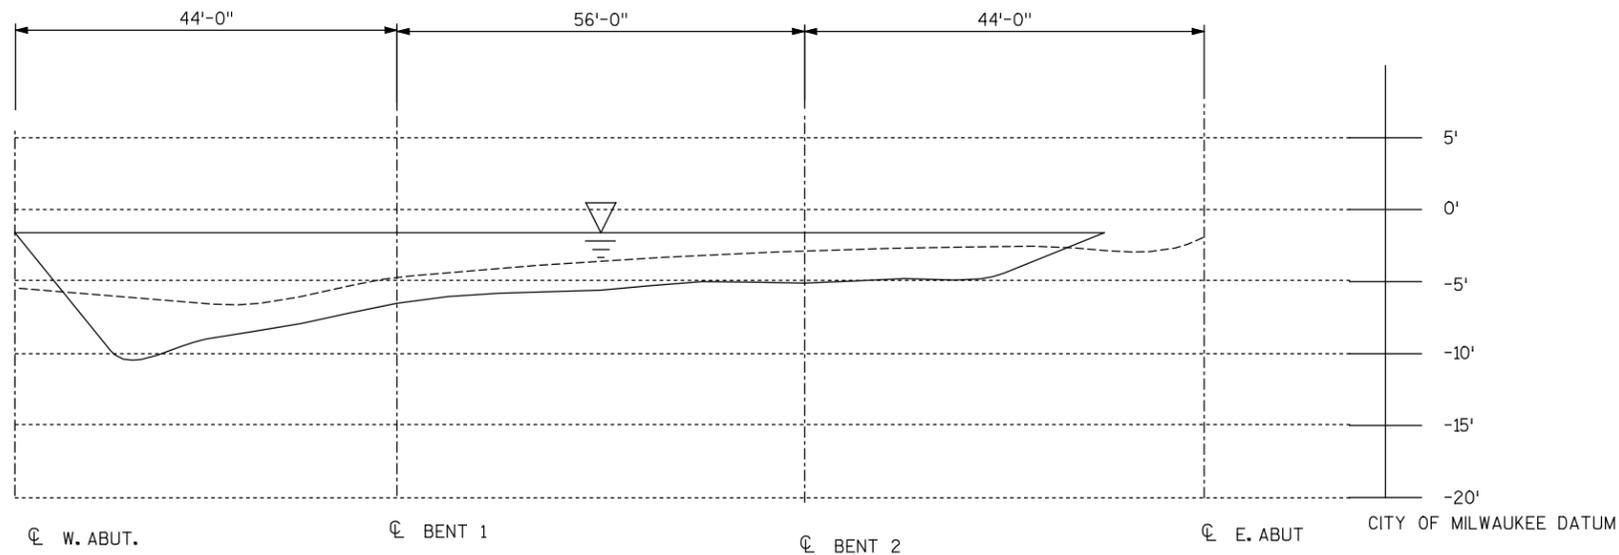
Date: JUNE 2008
 Scale: NTS
 Figure No.: 2

CHANNEL CROSS SECTION 200' UPSTREAM

CHANNEL CROSS SECTION 100' UPSTREAM

DISTANCE TO KNOWN EL. = -8.6'
 KNOWN EL. = 7.0'
 DESCRIPTION OF KNOWN EL.: TOP
 OF BENT CAP AT BENT 1
 WATERLINE EL. = -1.6'

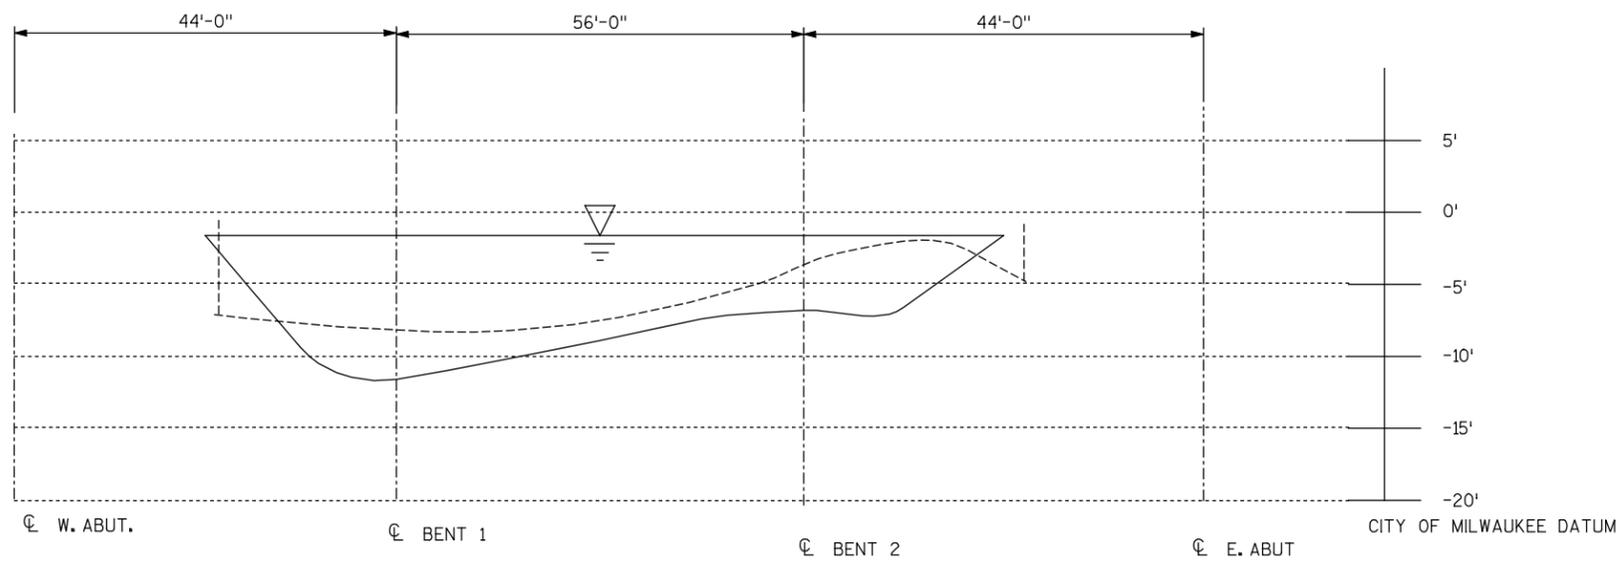
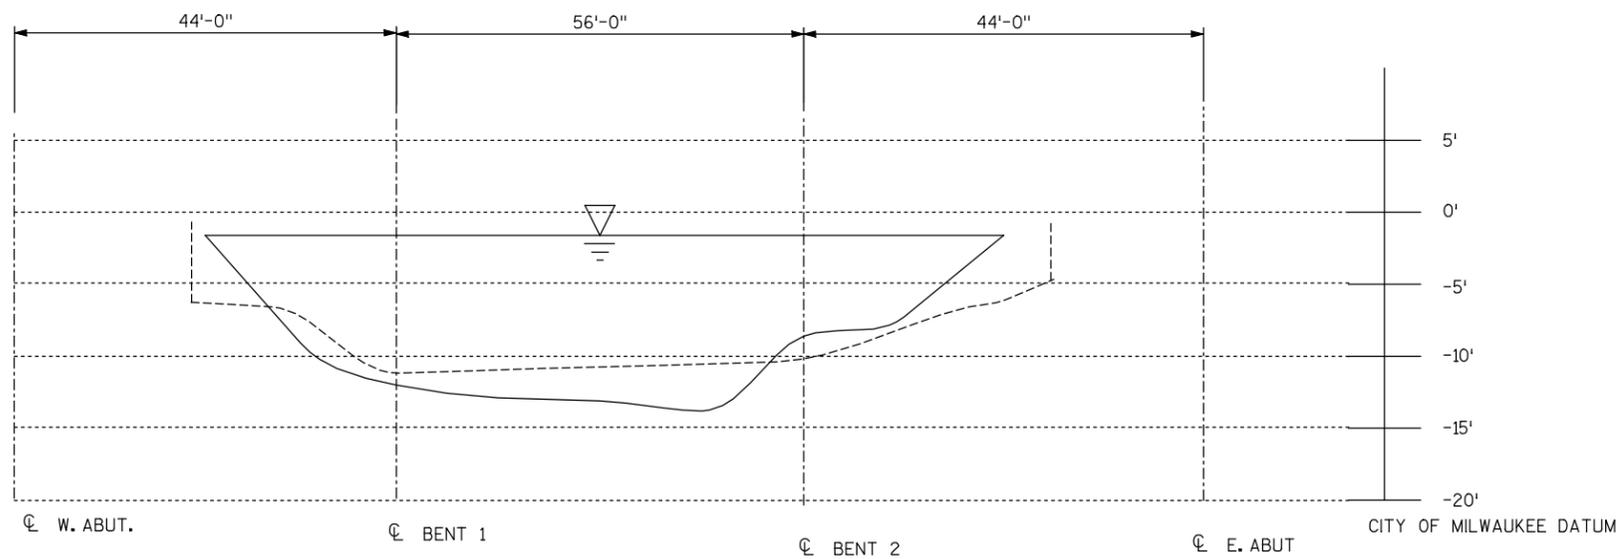
Date: JUNE 2008
 Scale: NTS
 Figure No.: 3

CHANNEL CROSS SECTION @ UPSTREAM FASCIA

CHANNEL CROSS SECTION @ DOWNSTREAM FASCIA

DISTANCE TO KNOWN EL. = -8.6'
 KNOWN EL. = 7.0'
 DESCRIPTION OF KNOWN EL.: TOP
 OF BENT CAP AT BENT 1
 WATERLINE EL. = -1.6'

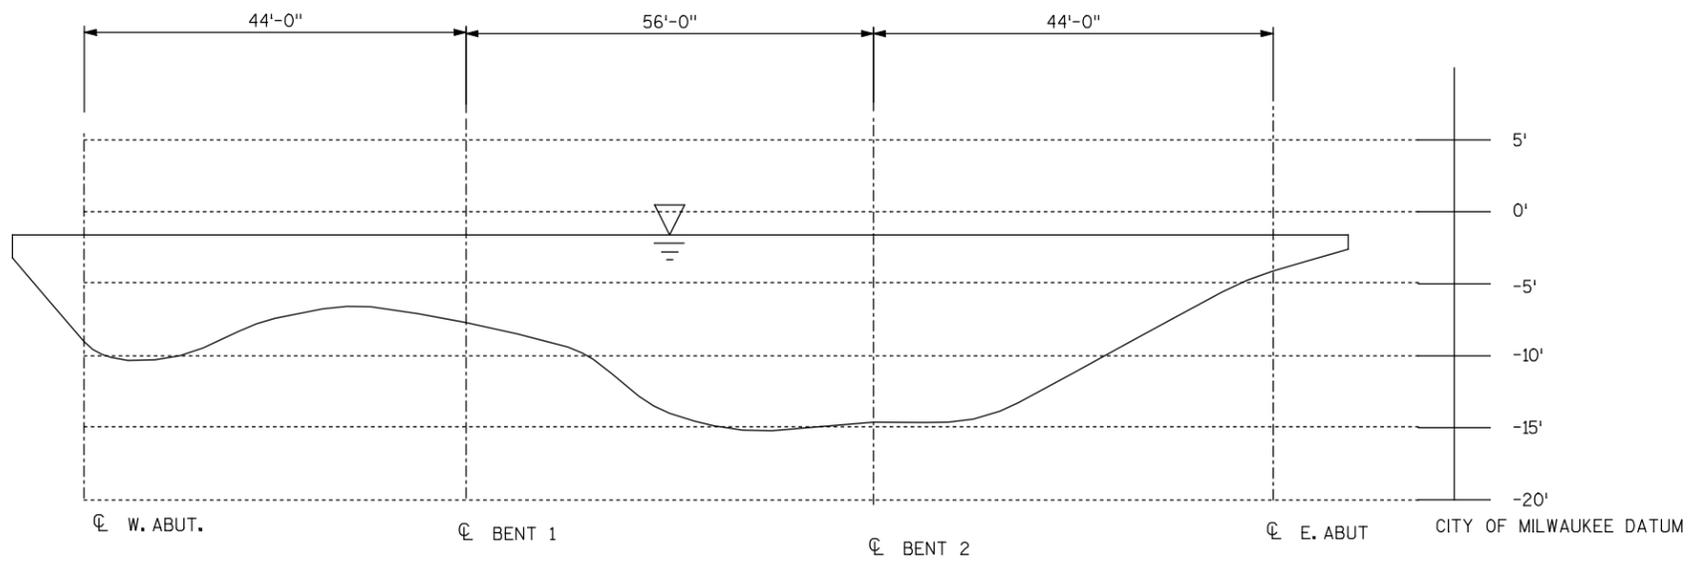
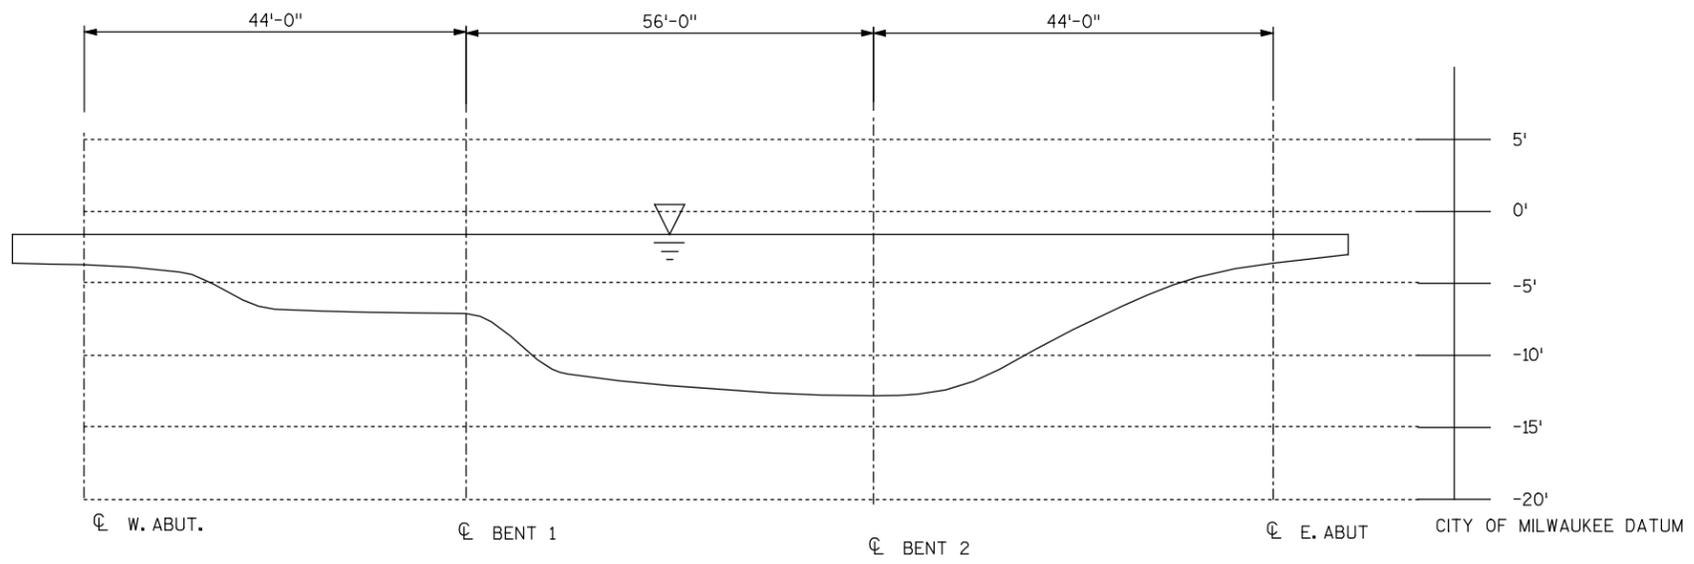
CHANNEL CROSS SECTION 100' DOWNSTREAM

CHANNEL CROSS SECTION 200' DOWNSTREAM

DISTANCE TO KNOWN EL. = -8.6'
 KNOWN EL. = 7.0'
 DESCRIPTION OF KNOWN EL.: TOP
 OF BENT CAP AT BENT 1
 WATERLINE EL. = -1.6'
